# *1st Rate Inspections LLC*

## Property Inspection Report

123 Anywhere, Spring, TX 77381  
Inspection prepared for: Mark Smith  
Real Estate Agent: -

Date of Inspection: 10/6/2014 Time: 8:30 AM  
Age of Home: 1985 Size: 2912  
Apprentice Inspector Tori Lange #20709

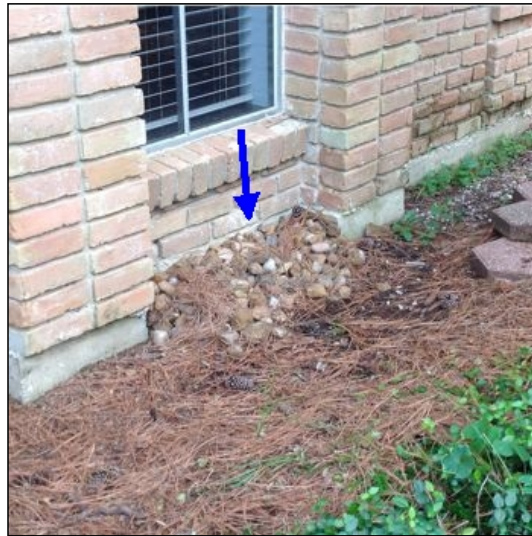
B.2. The soil level around the home is higher than recommended or in contact with the siding materials. Recommend lowering the soil line to help prevent water penetration and/or damage to the structure. Mainly at - fronts beds

The soil level around the home is higher than recommended or in contact with the siding materials. Recommend lowering the soil line to help prevent water penetration and/or damage to the structure. Mainly at - fronts beds

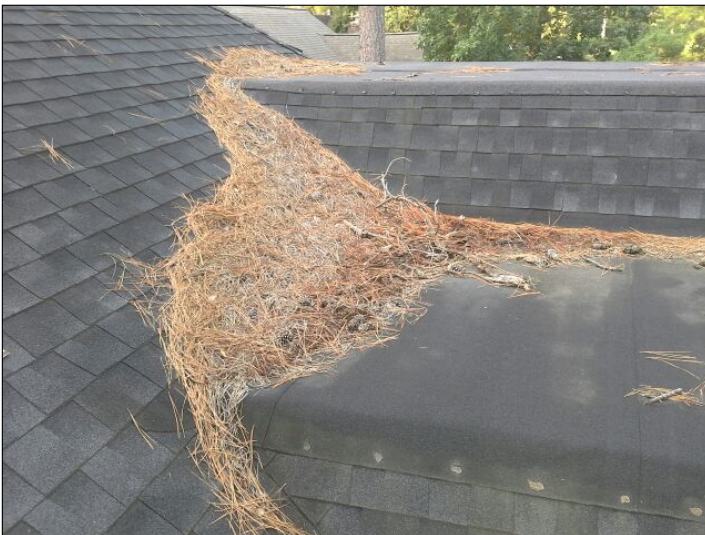
C.2. Debris were noted on the roof which can cause water to back up on the roof and allow water to penetrate through the roofing materials, recommend removing debris from roof. Unable to fully inspect roof covering as debris limit the visibility of the roof surface.

Debris were noted on the roof which can cause water to back up on the roof and allow water to penetrate through the roofing materials, recommend removing debris from roof. Unable to fully inspect roof covering as debris limit the visibility of the roof surface.

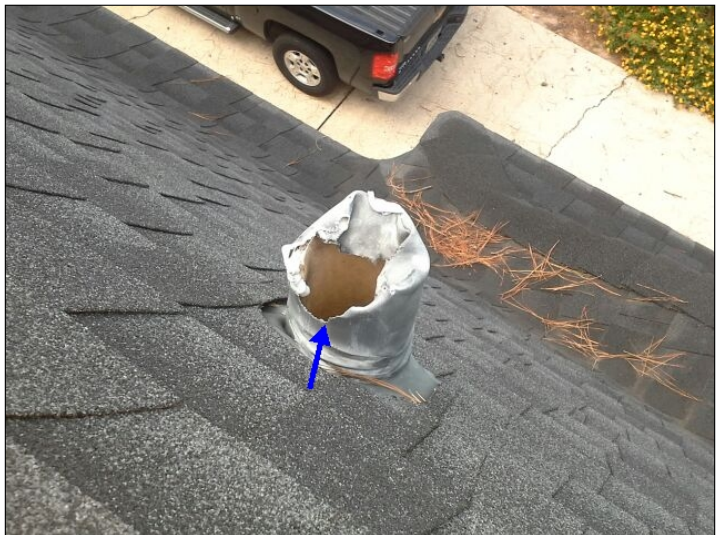
C.1. Damage was noted to the lead roof jack flashings. This is a common occurrence due to squirrels getting on roof, recommend a roofing specialist check all lead roof jacks for repair or replacement as needed depending on the extent of damage.

Damage was noted to the lead roof jack flashings. This is a common occurrence due to squirrels getting on roof, recommend a roofing specialist check all lead roof jacks for repair or replacement as needed depending on the extent of damage.

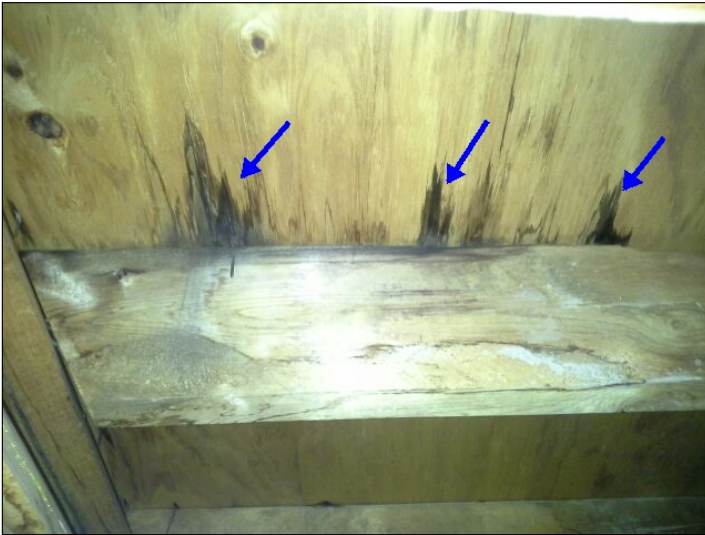
D.4. The roof decking was deteriorated slightly, recommend all deteriorated decking be replaced to help prevent further damage and water penetration into home. Mainly at - flat portion of the roof (May have been from previous roof)

The roof decking was deteriorated slightly, recommend all deteriorated decking be replaced to help prevent further damage and water penetration into home. Mainly at - flat portion of the roof (May have been from previous roof)

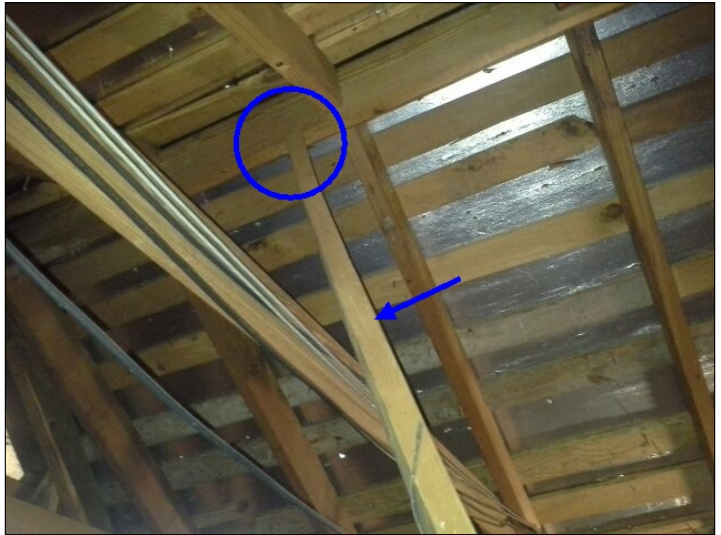
D.3. Attic vertical supports longer than 8' should have a T-style brace to limit amount of bowing in support. Also one is loose at the top connection (one extending over A/C unit)

Attic vertical supports longer than 8' should have a T-style brace to limit amount of bowing in support. Also one is loose at the top connection (one extending over A/C unit)

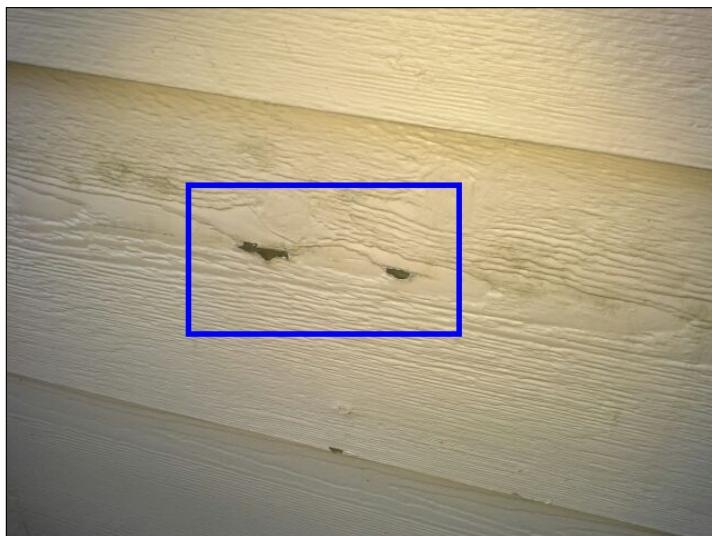
E.1. The home is in need of general painting and repairs of the siding and trim to help prevent moisture penetration and damage. Mainly at right side of garage

The home is in need of general painting and repairs of the siding and trim to help prevent moisture penetration and damage. Mainly at right side of garage

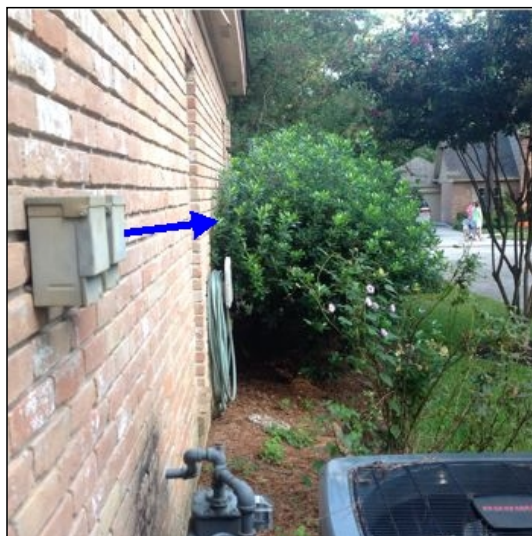
E.4. Recommend trimming vegetation so that it is not in contact with the house. Vegetation in contact with the structure can hold moisture against the structure and promote damage of building materials.

Recommend trimming vegetation so that it is not in contact with the house. Vegetation in contact with the structure can hold moisture against the structure and promote damage of building materials.

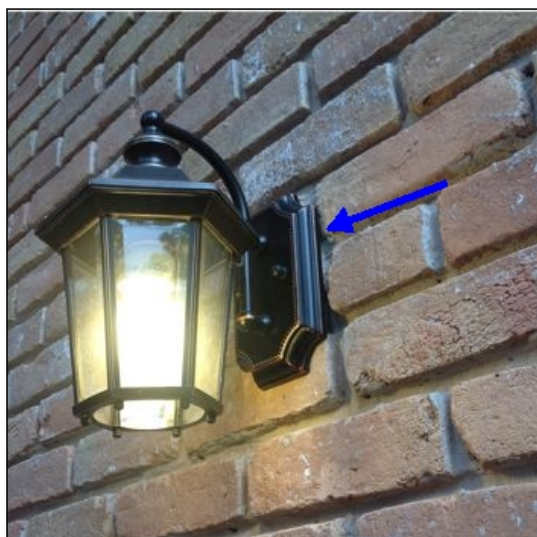
Seal all electrical lighting fixtures at wall connection to help prevent water penetration. It is a good idea to leave a small opening at the bottom to allow any water penetrating to escape.

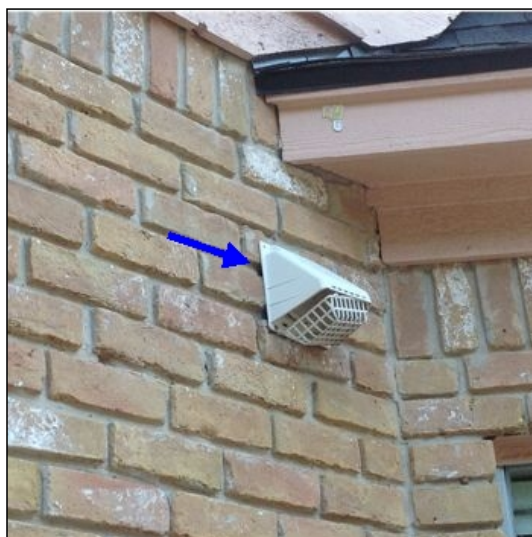
Seal all vents at wall connection to help prevent water penetration into walls.

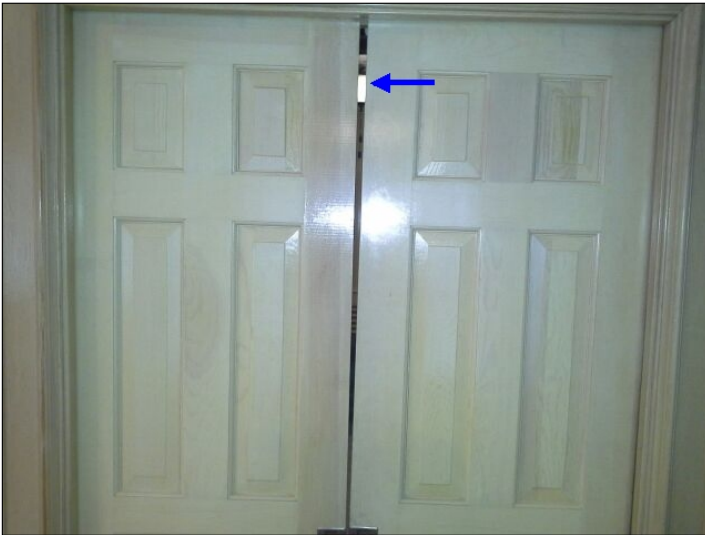
G.1. The kitchen pocket doors do not meet squarely in the center, recommend adjusting.

The kitchen pocket doors do not meet squarely in the center, recommend adjusting.

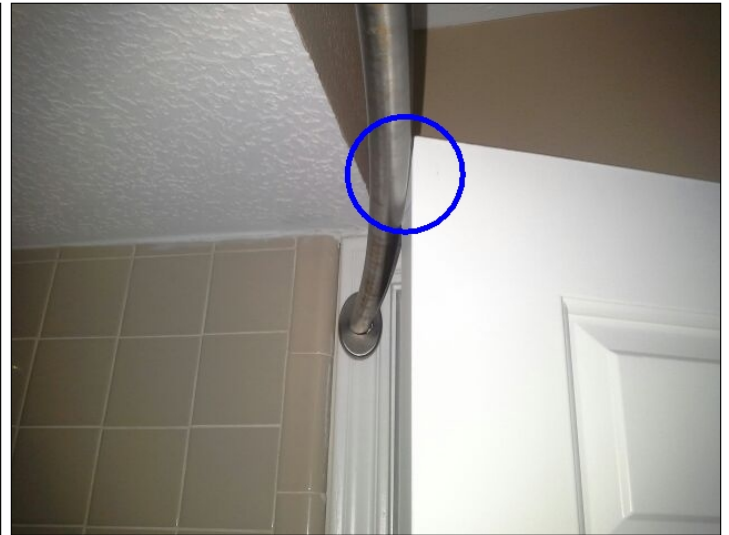
G.2. The door and the upstairs hall bath will not shut properly, it hits the hot shower rod.

The door and the upstairs hall bath will not shut properly, it hits the hot shower rod.

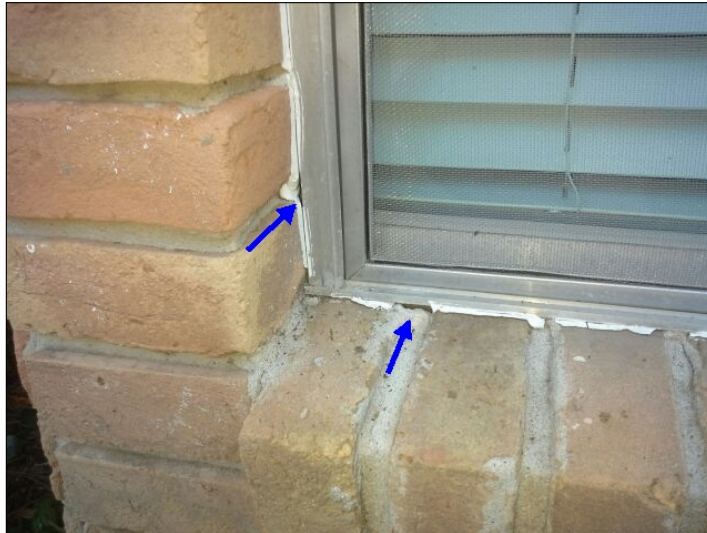
H.1. Sealant is needed around various windows between the window framing and exterior brickwork to help prevent water penetration, recommend checking all windows for proper sealant.

Sealant is needed around various windows between the window framing and exterior brickwork to help prevent water penetration, recommend checking all windows for proper sealant.

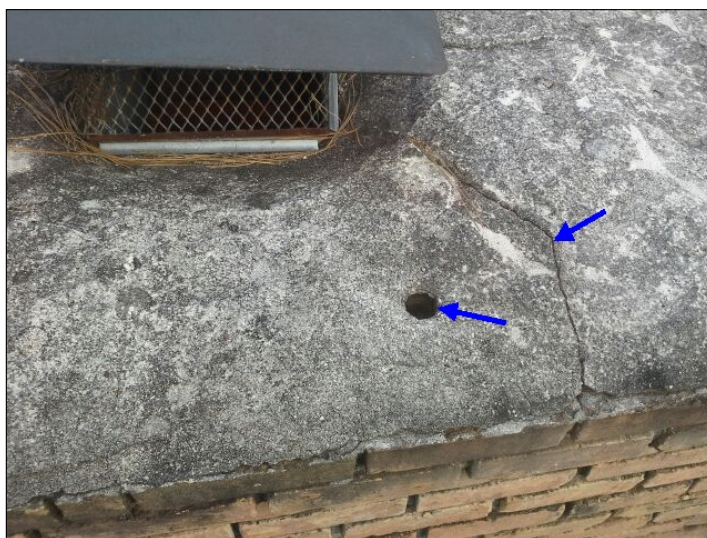
J.2. Seal all cracks and holes in mortar cap to help prevent further deterioration and water penetration.

Seal all cracks and holes in mortar cap to help prevent further deterioration and water penetration.

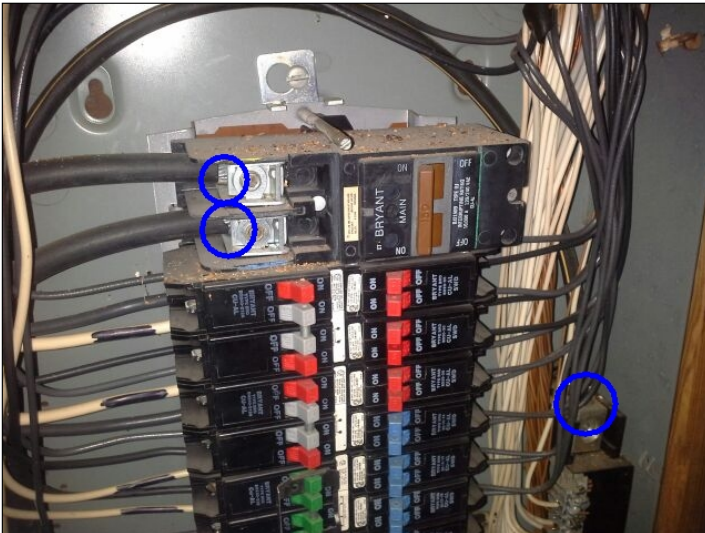
There is no antioxidant on main aluminum feeds to the panel box. This should be used to help prevent overheating.

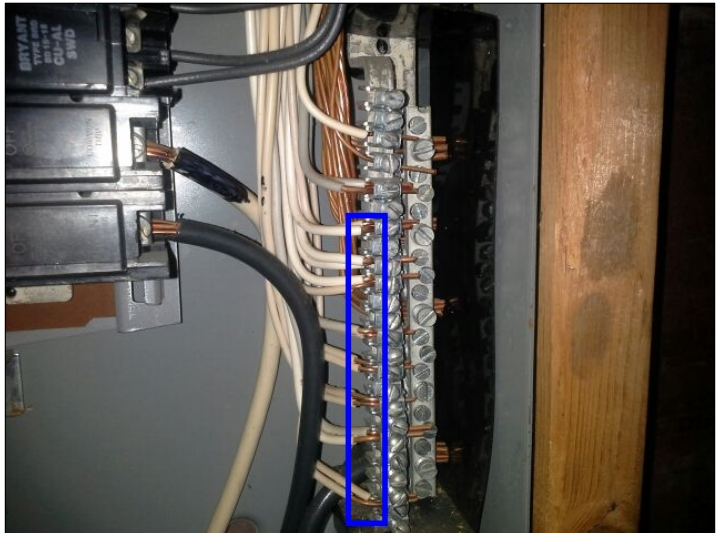
There are more than one neutral wire located under the same screw. Neutral wires should be separated to individual screws.

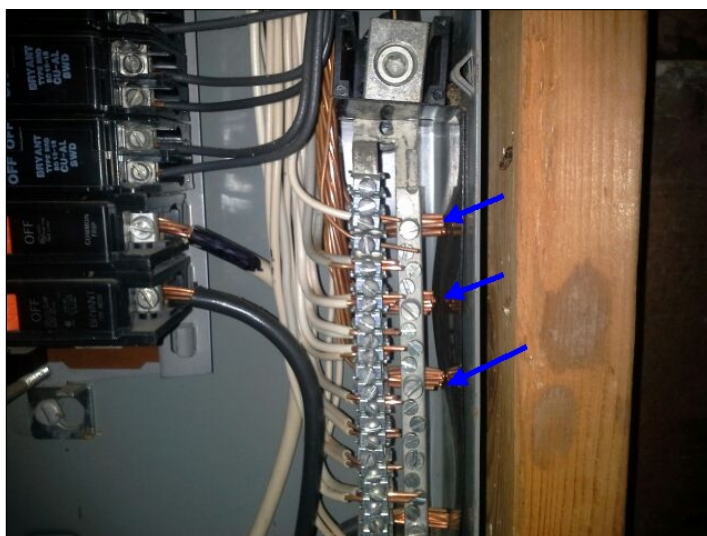
A.3. There are more than two ground wires located under the same screw on the ground bar. Ground wires should have no more than two wires under an individual screw.

There are more than two ground wires located under the same screw on the ground bar. Ground wires should have no more than two wires under an individual screw.

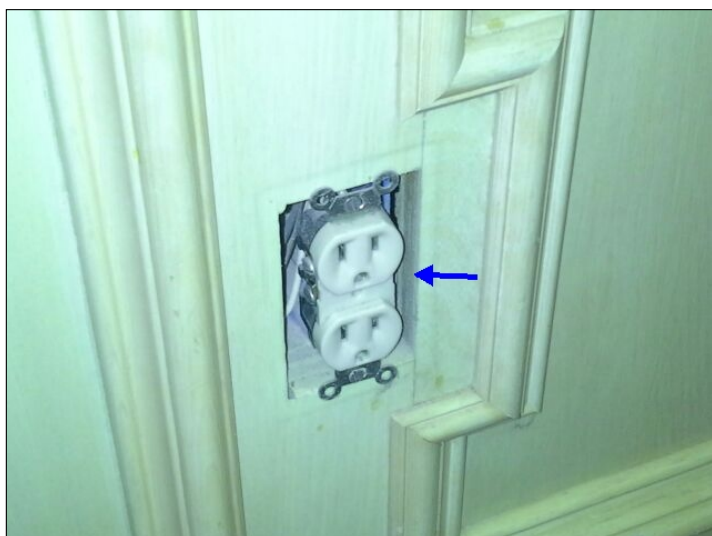
When installing electrical receptacles in combustible materials the box should be back set no more than 1/8th" from the surface to help prevent fire.

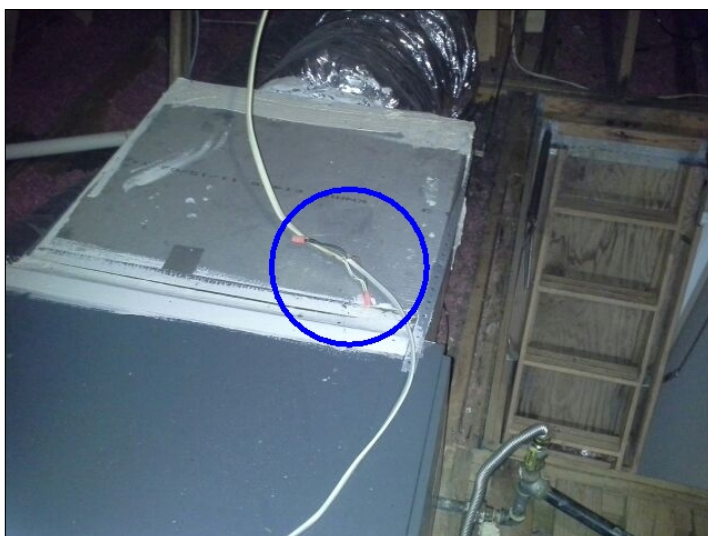
B.8. There are visible unprotected wiring splices. Recommend the wiring be properly enclosed. Mainly at - main attic

There are visible unprotected wiring splices. Recommend the wiring be properly enclosed. Mainly at - main attic

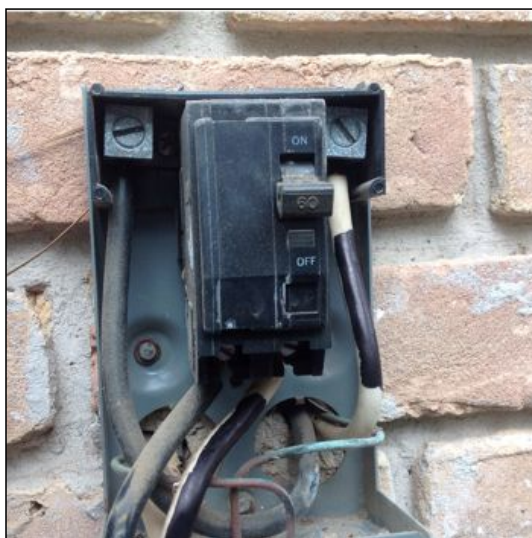
Line and loads wires are reversed on A/C disconnect. Mainly at- right unit

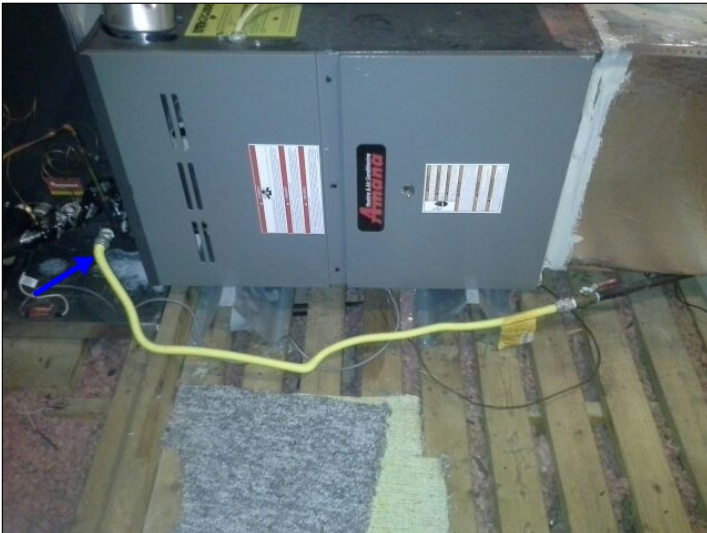
There is no drip leg or sediment trap for gas line on the furnace. This helps prevent trash from clogging jets.

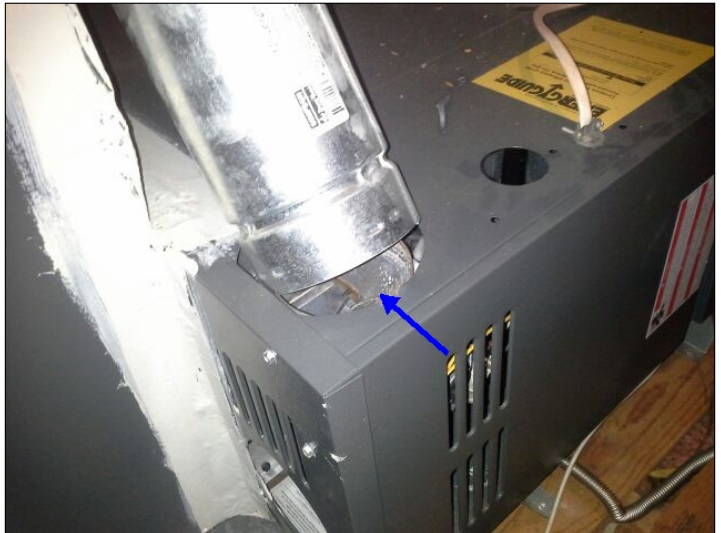
A.3. The vent pipe for the furnace is loose or separated causing a carbon monoxide to leak in the surrounding area. This can be dangerous or fatal if not corrected, recommend a heating specialist for immediate repairs.

The vent pipe for the furnace is loose or separated causing a carbon monoxide to leak in the surrounding area. This can be dangerous or fatal if not corrected, recommend a heating specialist for immediate repairs.

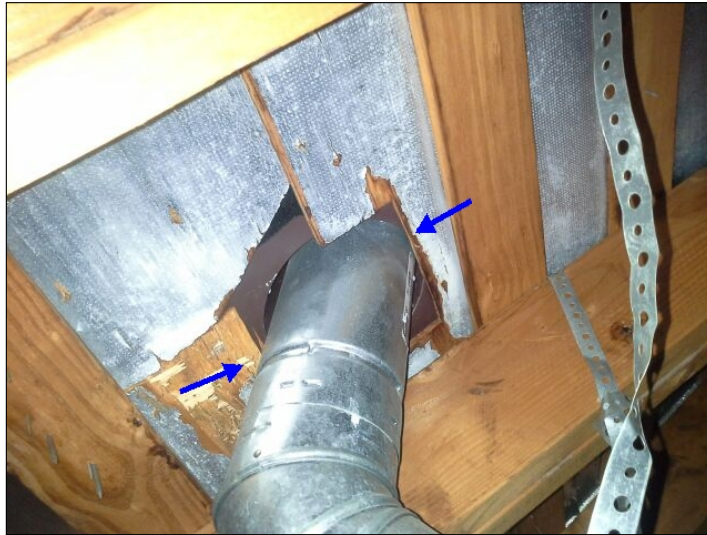
A.2. There is improper clearance to combustibles around the flue pipe. Upstairs unit

There is improper clearance to combustibles around the flue pipe.  
Upstairs unit

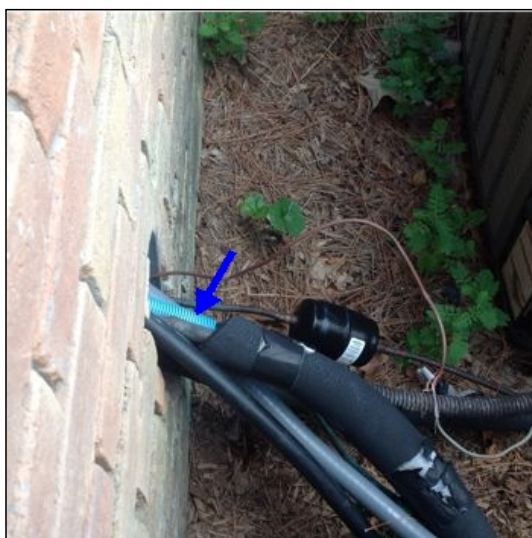
B.4. The insulation is missing or damaged on the A/C suction line at the condensing unit. Recommend repair or replacement to prevent cooling loss from exterior temperatures.

The insulation is missing or damaged on the A/C suction line at the condensing unit. Recommend repair or replacement to prevent cooling loss from exterior temperatures.

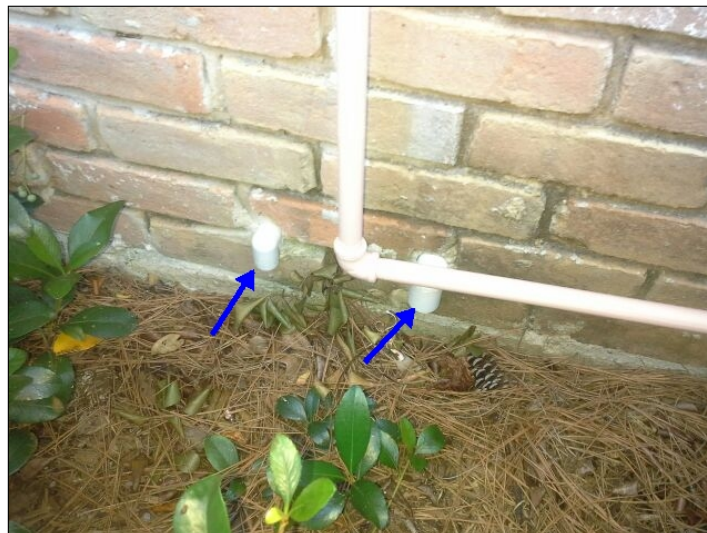
A.1. Recommend painting all exposed plastic pipe to prevent premature deterioration from UV rays.

Recommend painting all exposed plastic pipe to prevent premature deterioration from UV rays.

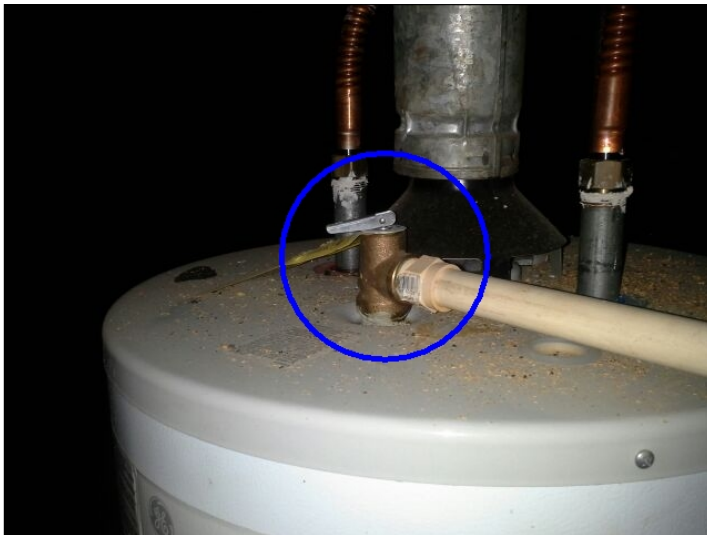
C.1. The T&P (Temperature & Pressure relief valve) is not opening under normal pressure, this usually means that it may not function as intended when needed and should be replaced. It is recommended by the manufacture that the T&P valve be replaced every three years.

The T&P (Temperature & Pressure relief valve) is not opening under normal pressure, this usually means that it may not function as intended when needed and should be replaced. It is recommended by the manufacture that the T&P valve be replaced every three years.

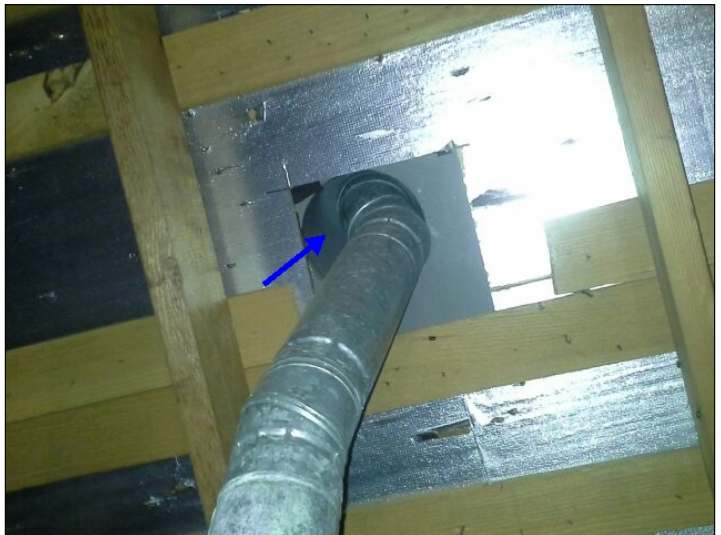
C.3. The gas water heater is not properly vented, the furnace should be vented with double wall vent pipe through the roof with a rain collar installed above the roof jack sealed and terminated with a type B vent cap. This can be a fire hazard if not corrected recommend a licensed plumer for corrective action immediately.

The gas water heater is not properly vented, the furnace should be vented with double wall vent pipe through the roof with a rain collar installed above the roof jack sealed and terminated with a type B vent cap. This can be a fire hazard if not corrected recommend a licensed plumer for corrective action immediately.
