Property Inspection Report

123 Future Home Dr, Some Town, TX, 12345

Inspection Date: 6/16/2023

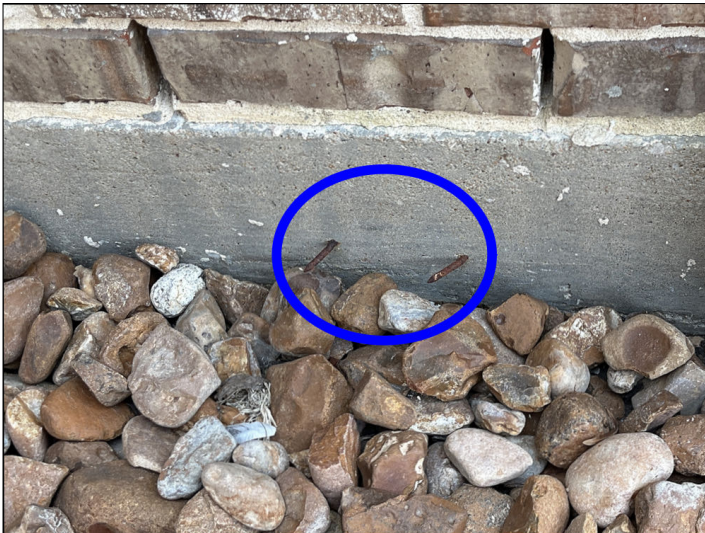
A.3. Nails were sticking out of the slab, recommend these nail be cut or ground off to help prevent damage or injury.

Nails were sticking out of the slab, recommend these nail be cut or ground off to help prevent damage or injury.

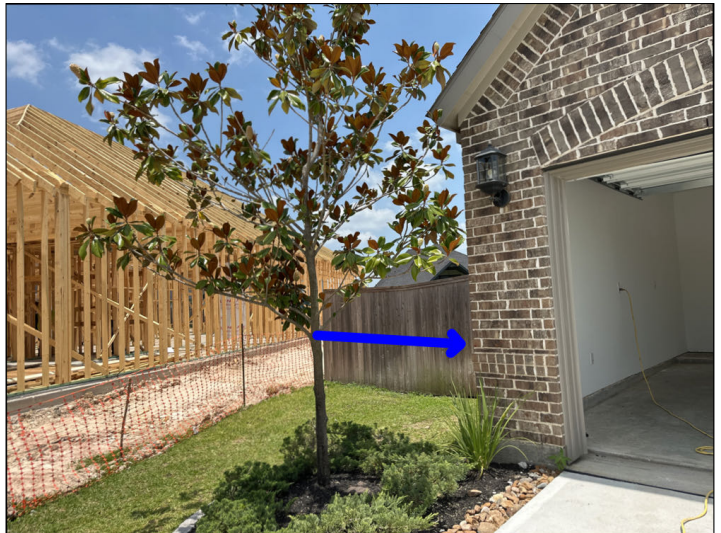
A.1. All trees should be located no closer than 15' from structure to help prevent foundation movement. You may want to keep larger trees trimmed to help slow further root growth and future foundation movement as removing older trees may cause voids under the slab from dying root systems.

All trees should be located no closer than 15' from structure to help prevent foundation movement. You may want to keep larger trees trimmed to help slow further root growth and future foundation movement as removing older trees may cause voids under the slab from dying root systems.

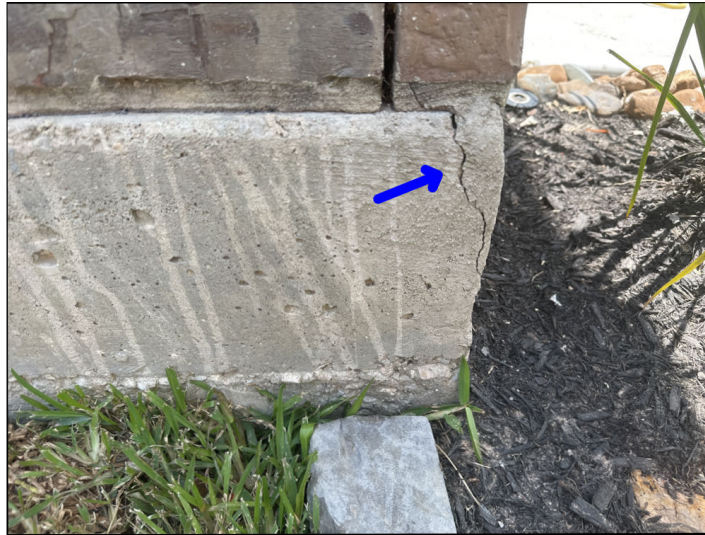
A.2. Corner pops were noted on one or more corners of the foundation. These are usually considered cosmetic in nature unless other movement is noted. Recommend sealing all cracks to help prevent further deterioration.

Corner pops were noted on one or more corners of the foundation. These are usually considered cosmetic in nature unless other movement is noted. Recommend sealing all cracks to help prevent further deterioration.

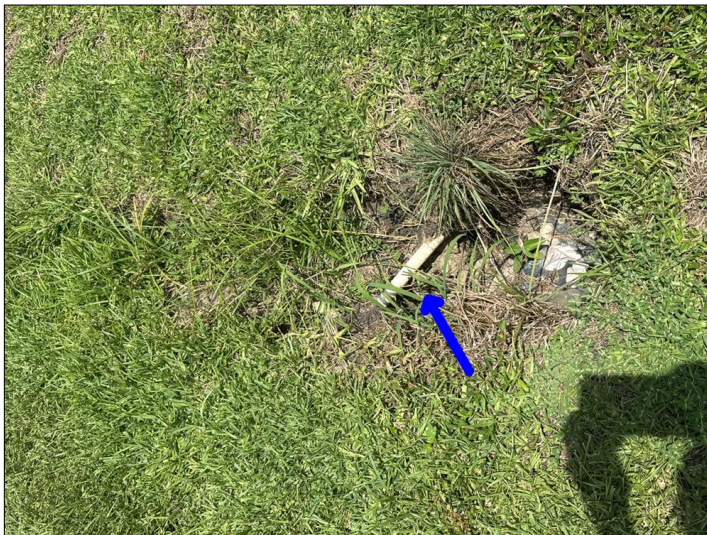
There are indications of some type of water pipe leak at the right rear of the home. Recommend contacting the builder to evaluate and repair as needed.

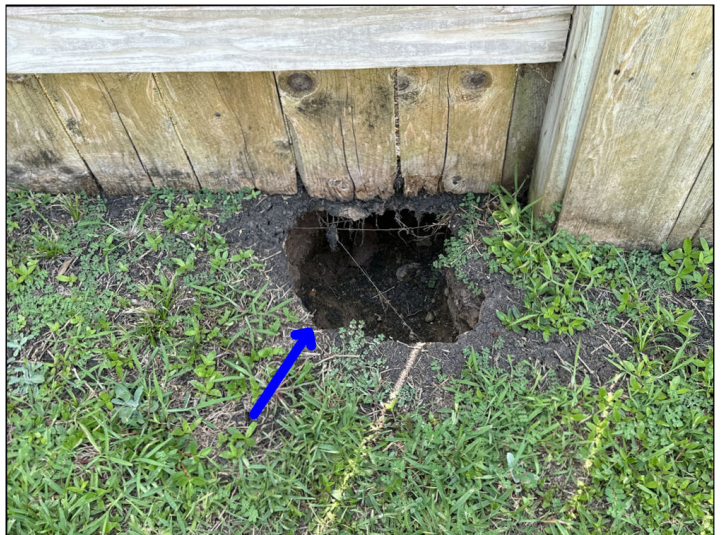
There are indications of some type of water pipe leak at the right rear of the home. Recommend contacting the builder to evaluate and repair as needed.

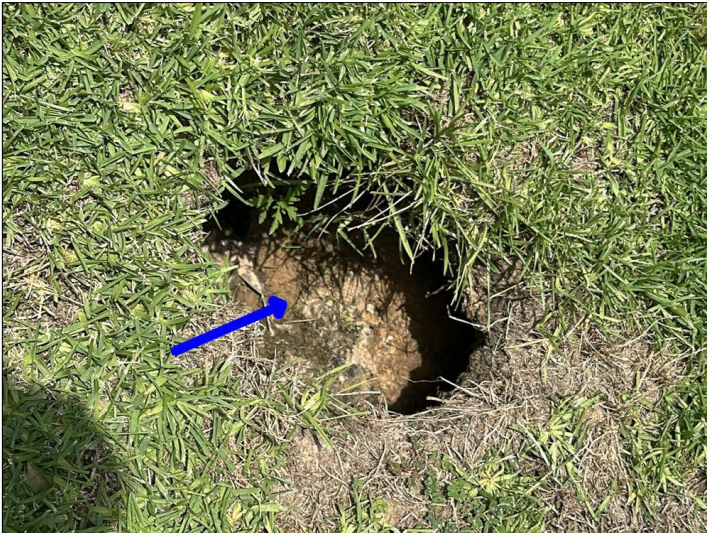
There are indications of some type of water pipe leak at the right rear of the home. Recommend contacting the builder to evaluate and repair as needed.

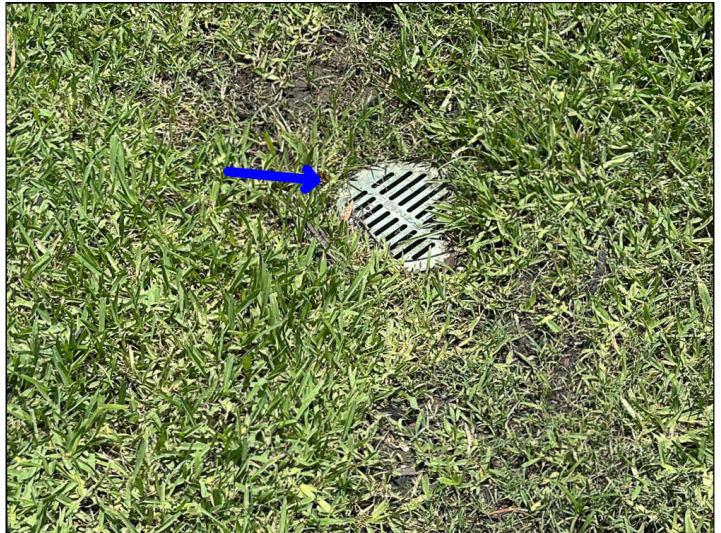
B.1. Surface drains have been noted on the property. We can not determine the condition of drains that are below grade level. Mainly at - right

Surface drains have been noted on the property. We can not determine the condition of drains that are below grade level. Mainly at - right

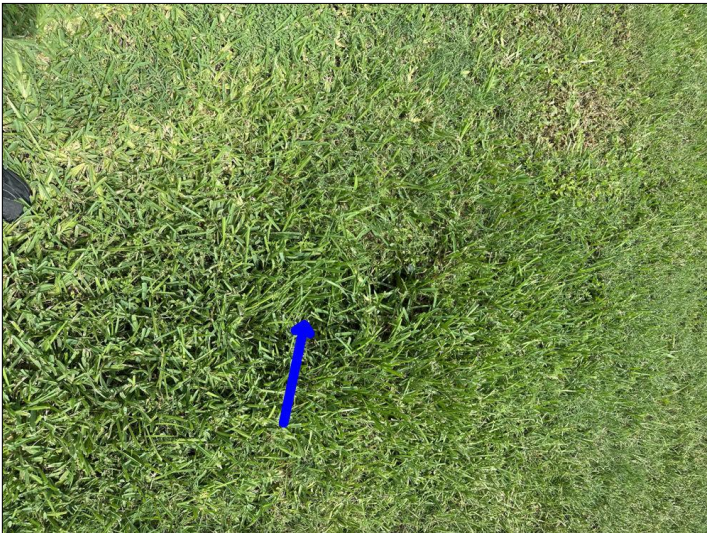
There are indications of some type of water pipe leak at the right rear of the home. Recommend contacting the builder to evaluate and repair as needed. Ther is also some that the grass has grown over about 4' from left fence.

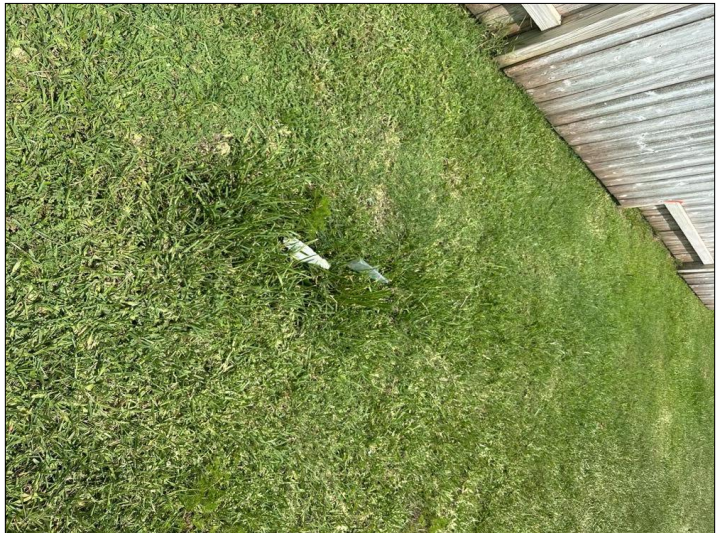
B.2. There are indications of some type of water pipe leak at the right rear of the home. Recommend contacting the builder to evaluate and repair as needed.

There are indications of some type of water pipe leak at the right rear of the home. Recommend contacting the builder to evaluate and repair as needed.

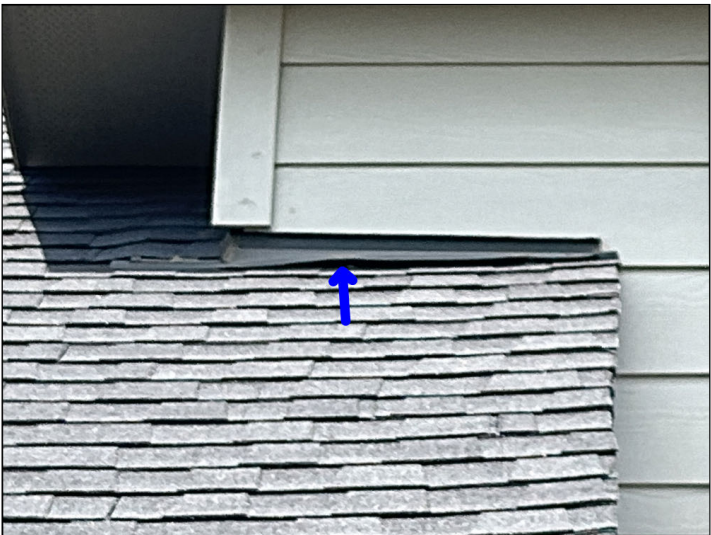
C.1. The roof flashing is lifted. Recommend securing all loose or lifted flashing and sealing nails to help prevent water penetration. Mainly at - right

The roof flashing is lifted. Recommend securing all loose or lifted flashing and sealing nails to help prevent water penetration. Mainly at - right

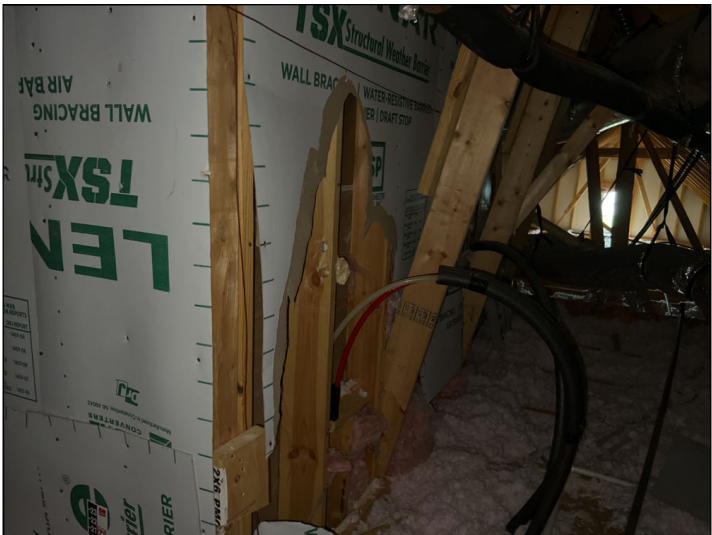
D.1. Insulation has been removed from vertical surfaces or been misplaced in one or more areas of the attic, recommend all displaced insulation be replaced to restore to proper energy efficiency. Mainly at - 2nd floor attic

Insulation has been removed from vertical surfaces or been misplaced in one or more areas of the attic, recommend all displaced insulation be replaced to restore to proper energy efficiency.
Mainly at - 2nd floor attic

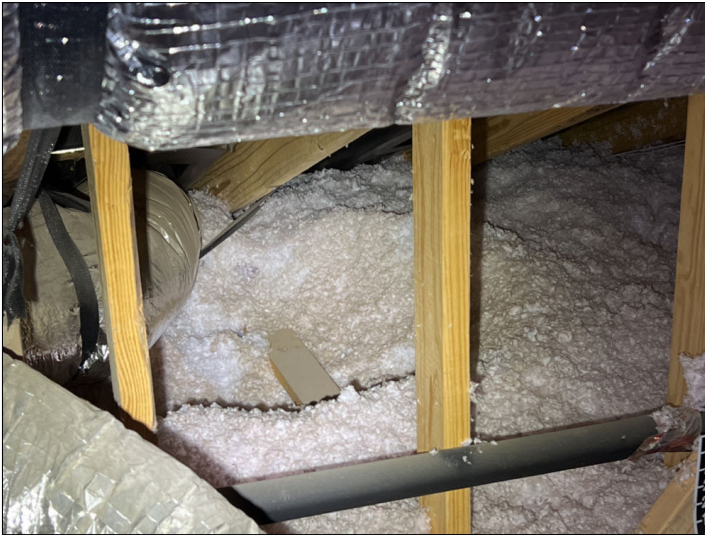
D.2. Rodent/Pest activity was observed in the attic space. Trails and holes through the insulation is a good indication that rodents have been in the attic at some point. There may have also been indications of fecal matter or an assortment of traps noted in the attic which would allude to the presence of pest activity. The inspector is unable to determine if this is an active or past condition and is beyond the scope of a home inspection. We recommend that a pest control specialist be consulted for a determination of present conditions and possibly performing an exclusion which is closing off all holes or places of entry to help prevent rodent/pest infestation.

Rodent/Pest activity was observed in the attic space. Trails and holes through the insulation is a good indication that rodents have been in the attic at some point. There may have also been indications of fecal matter or an assortment of traps noted in the attic which would allude to the presence of pest activity. The inspector is unable to determine if this is an active or past condition and is beyond the scope of a home inspection. We recommend that a pest control specialist be consulted for a determination of present conditions and possibly performing an exclusion which is closing off all holes or places of entry to help prevent rodent/pest infestation.

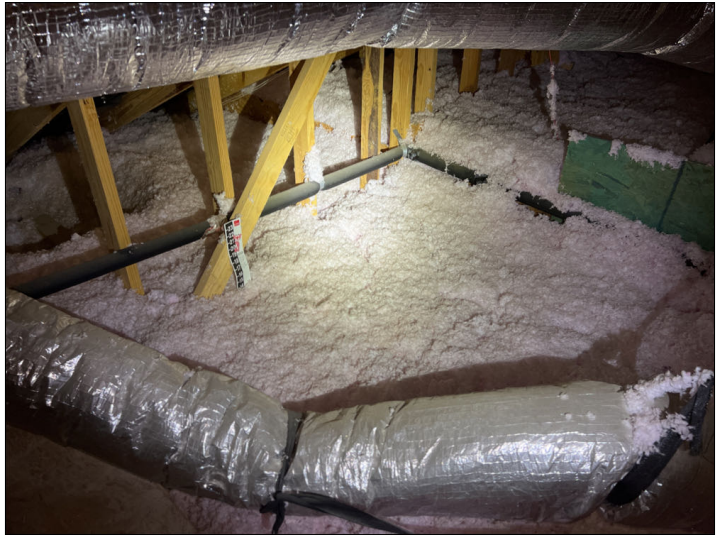
Rodent/Pest activity was observed in the attic space. Trails and holes through the insulation is a good indication that rodents have been in the attic at some point. There may have also been indications of fecal matter or an assortment of traps noted in the attic which would allude to the presence of pest activity. The inspector is unable to determine if this is an active or past condition and is beyond the scope of a home inspection. We recommend that a pest control specialist be consulted for a determination of present conditions and possibly performing an exclusion which is closing off all holes or places of entry to help prevent rodent/pest infestation.

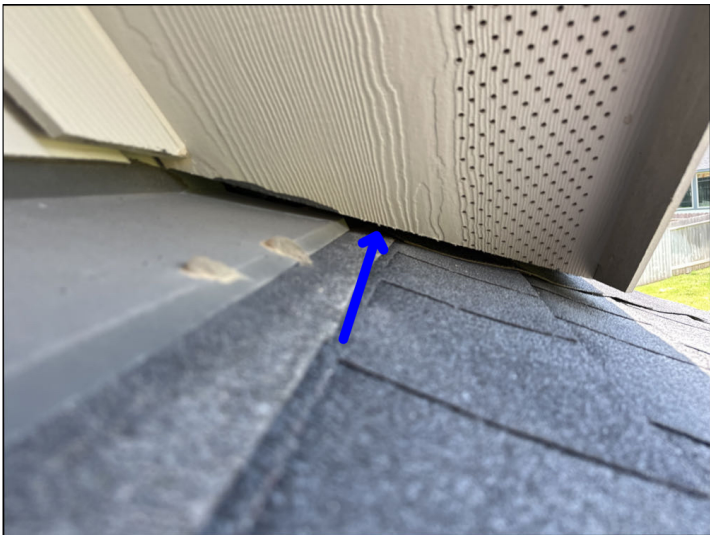
Seal gaps and holes in soffit to help prevent water penetration and rodent intrusion. Mainly at - rear

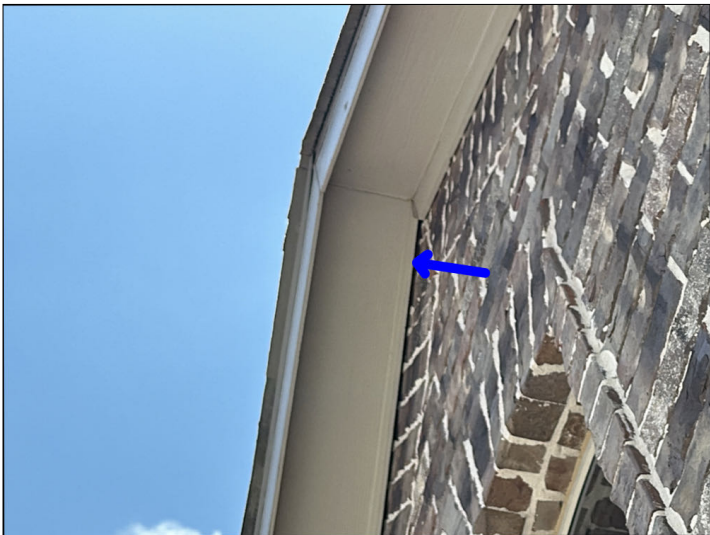
E.3. There is loose trim on the home, recommend securing to help prevent future damage and water penetration. Mainly at - front (may be secure but gapped at the ridge of garage)

There is loose trim on the home, recommend securing to help prevent future damage and water penetration. Mainly at - front (may be secure but gapped at the ridge of garage)

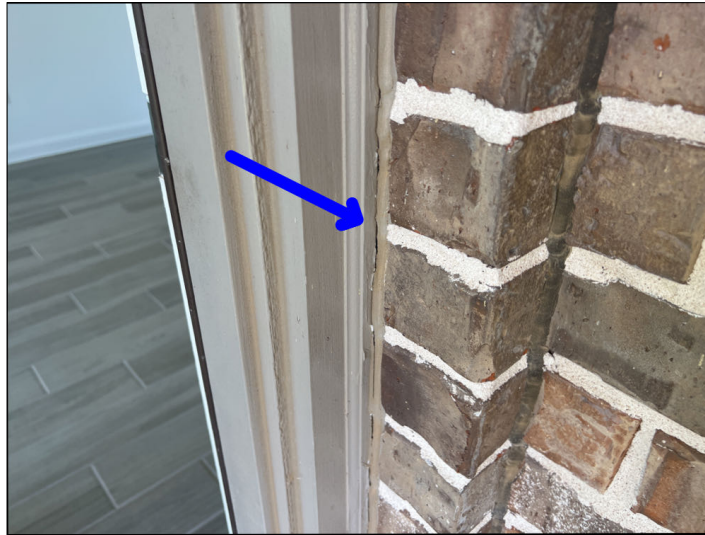
E.1. Recommend sealing between the trim and brickwork to help prevent water penetration. Mainly at - Rear door

Recommend sealing between the trim and brickwork to help prevent water penetration. Mainly at - Rear door

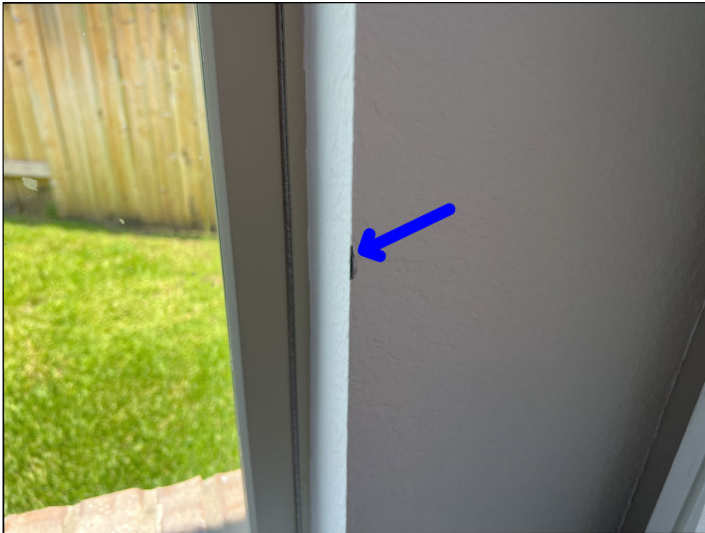
Paint is chipped on the window casing. Mainly at -
Right middle bedroom

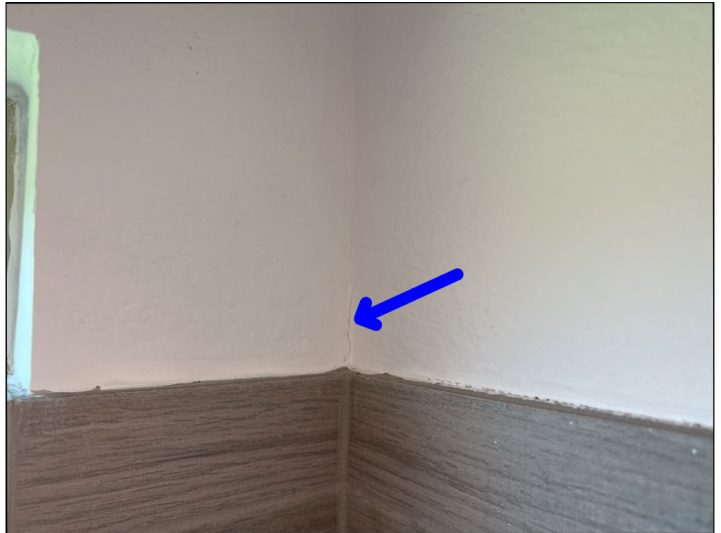
Settlement cracks were noted in the drywall.
Mainly at - Hall bath

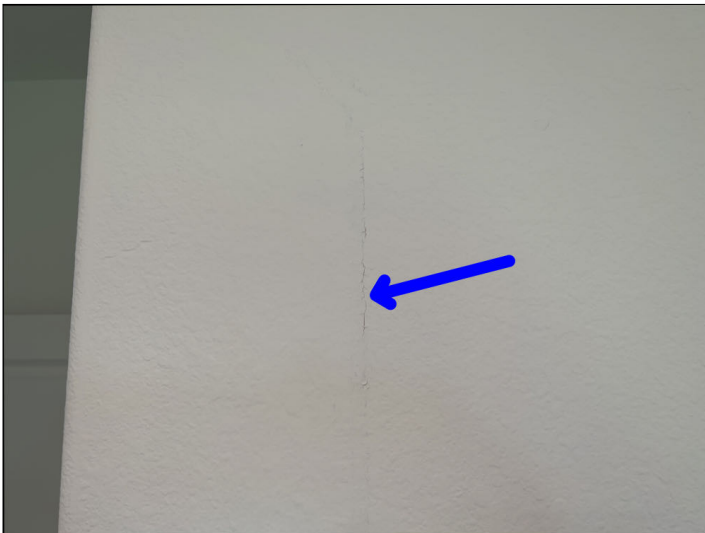
F.1. Per the Residential Construction Performance Guidelines Section 10-6; The contractor shall repair or correct blemishes and or incorrect application of wall coverings, including but not limited to tape and float joint compounds, texture and paint. Any such blemishes that are readily visible from a standing position facing the surface at a distance of 6 feet under normal lighting conditions are to be considered excessive. Recommend a full evaluation of the drywall installation and the texture and paint application throughout the home.

Per the Residential Construction Performance Guidelines Section 10-6; The contractor shall repair or correct blemishes and or incorrect application of wall coverings, including but not limited to tape and float joint compounds, texture and paint. Any such blemishes that are readily visible from a standing position facing the surface at a distance of 6 feet under normal lighting conditions are to be considered excessive. Recommend a full evaluation of the drywall installation and the texture and paint application throughout the home.

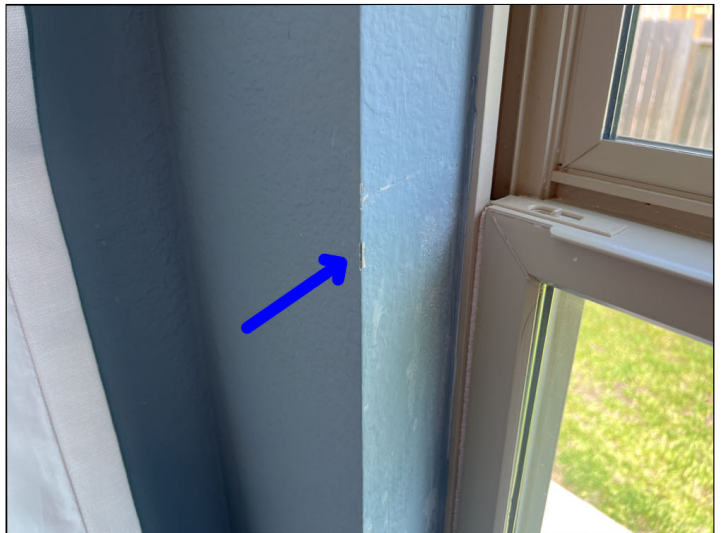
Paint is chipped on the window casing. Mainly at -
Formal Dining Room

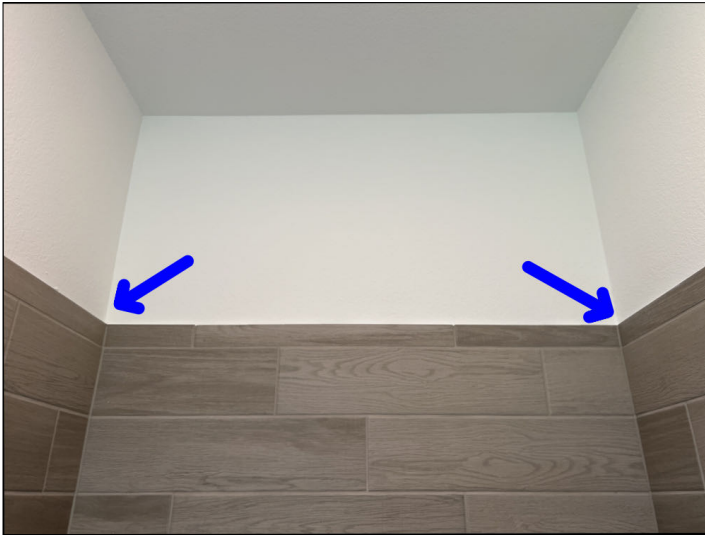
F.2. Settlement cracks were noted in the drywall. Mainly at - Hall bath, Master shower stall

Settlement cracks were noted in the drywall.
Mainly at - Master shower stall

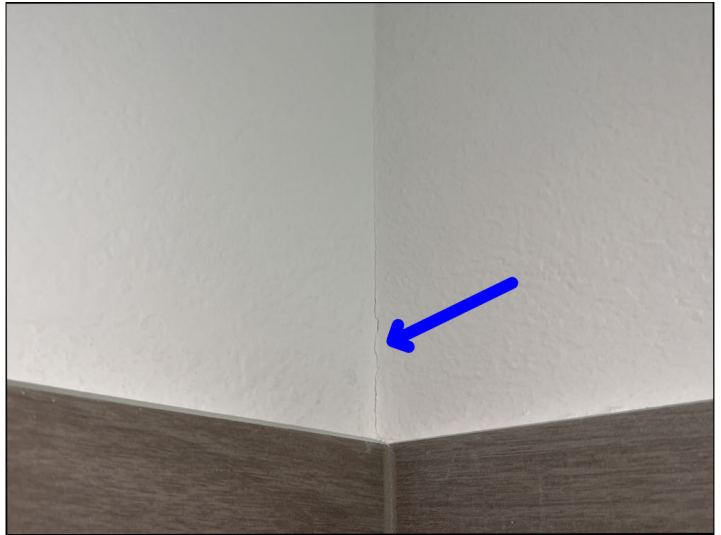
Settlement cracks were noted in the drywall.
Mainly at - Master shower stall

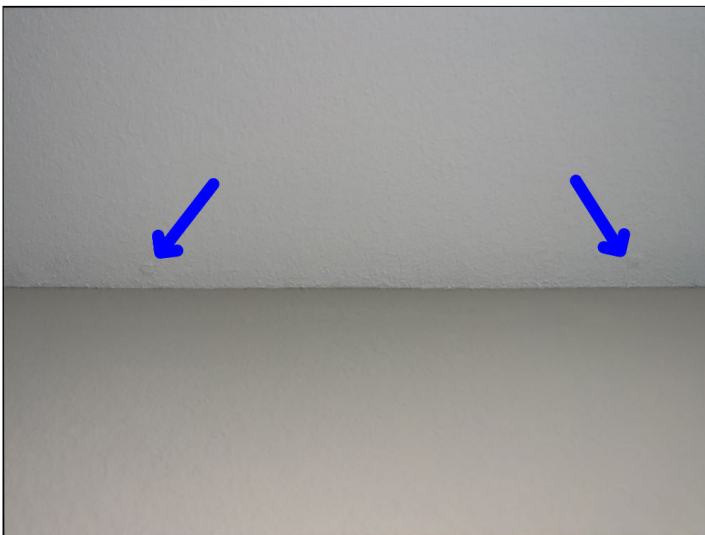
G.2. Nail pops were noted in the ceiling. These are generally considered cosmetic only, unless otherwise noted. Mainly at - Right middle bedroom, Dining room, Master bedroom

Nail pops were noted in the ceiling. These are generally considered cosmetic only, unless otherwise noted. Mainly at - Right middle bedroom

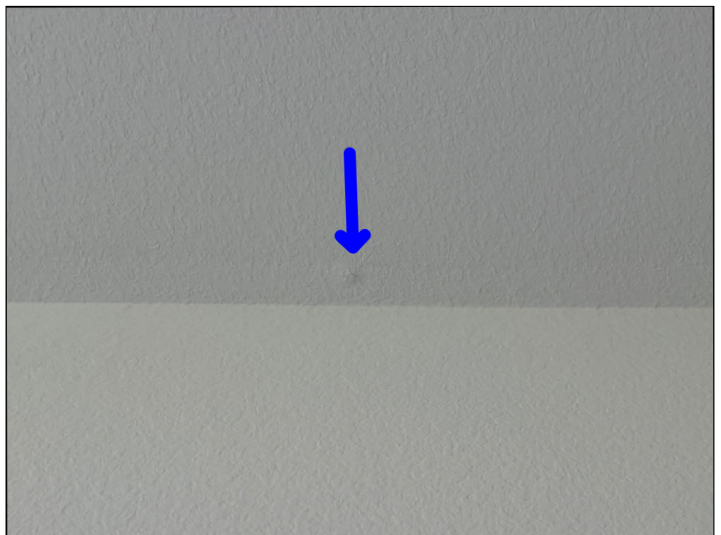
Nail pops were noted in the ceiling. These are generally considered cosmetic only, unless otherwise noted. Mainly at - Dining room

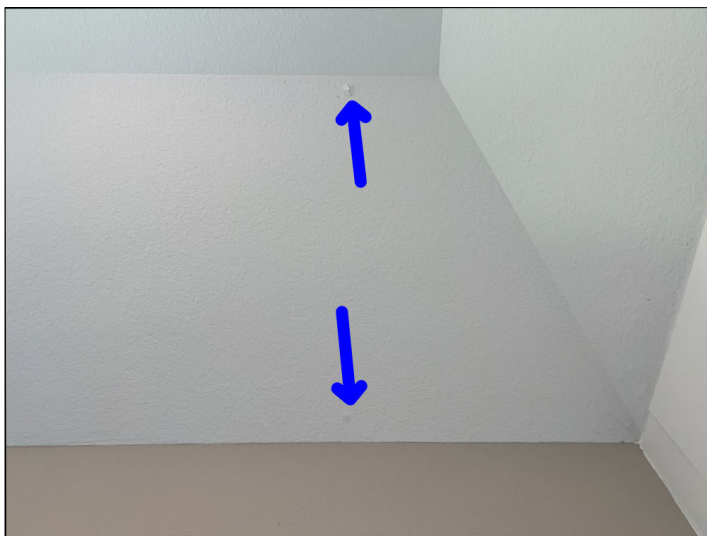
Nail pops were noted in the ceiling. These are generally considered cosmetic only, unless otherwise noted. Mainly at - Master bedroom

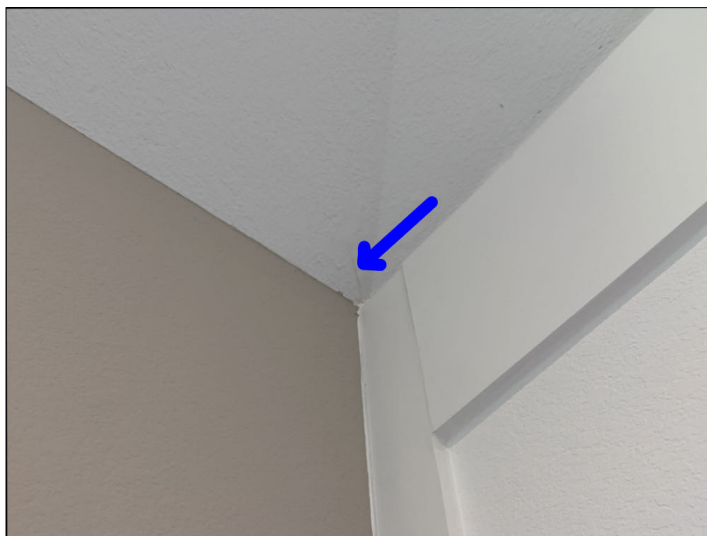
G.1. Settlement cracks were noted in the drywall. These are generally considered cosmetic only, unless otherwise noted. Mainly at - Master bedroom

Settlement cracks were noted in the drywall. These are generally considered cosmetic only, unless otherwise noted. Mainly at - Master bedroom

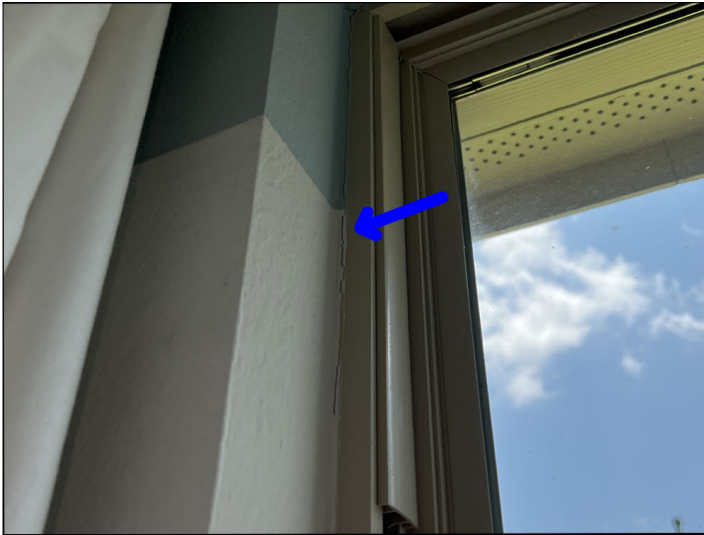
Sealant is needed around the interior of the windows between the window framing and the drywall to help prevent water penetration. Mainly at - Right middle bedroom

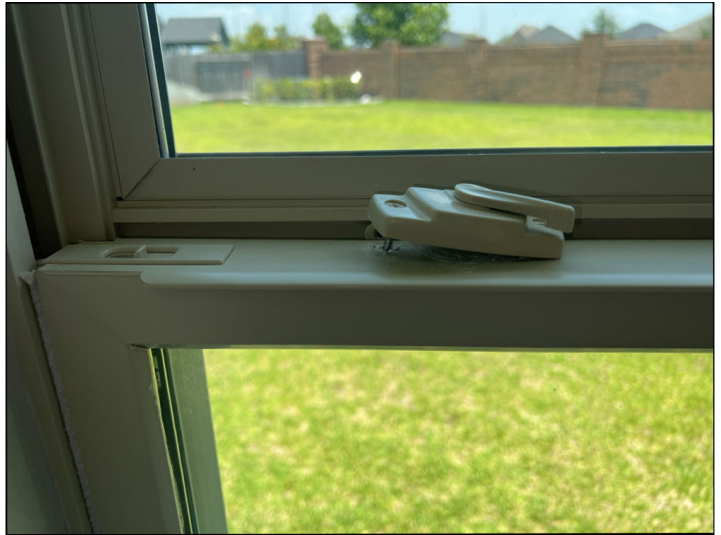
J.2. The window lock/latch is damaged. Mainly at - Master bedroom

The window lock/latch is damaged. Mainly at - Master bedroom

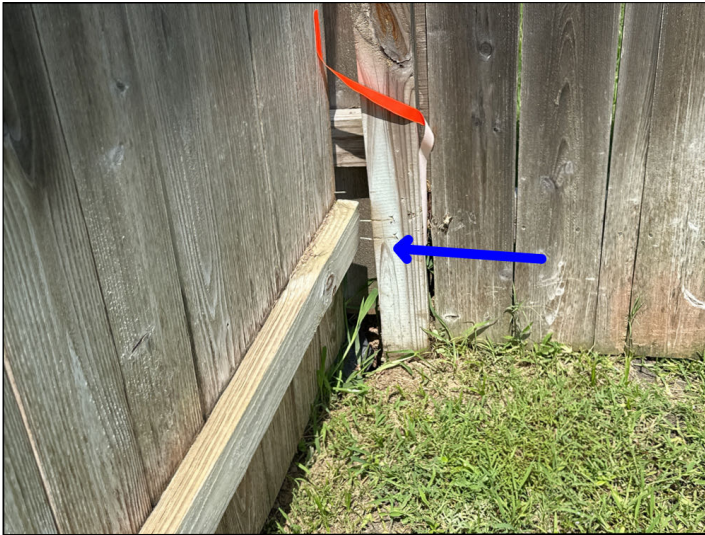
N.2. Although fences are not inspected it was noted that the fence is showing some signs of damage or deterioration. (One of the panels is not nailed properly at the left rear corner)

Although fences are not inspected it was noted that the fence is showing some signs of damage or deterioration. (One of the panels is not nailed properly at the left rear corner)

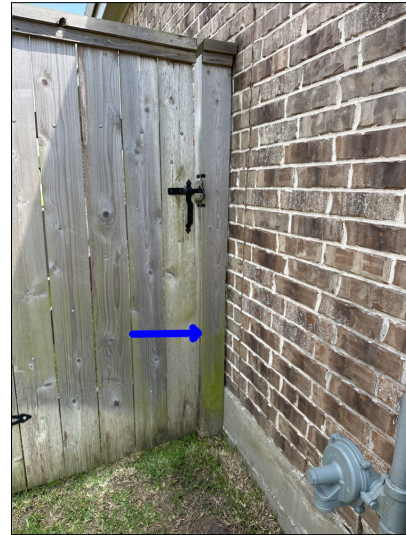
N.1. Although fences are not inspected it was noted that the fence is showing some signs of damage or deterioration. (The post is loose at the gate latch)

Although fences are not inspected it was noted that the fence is showing some signs of damage or deterioration. (The post is loose at the gate latch)

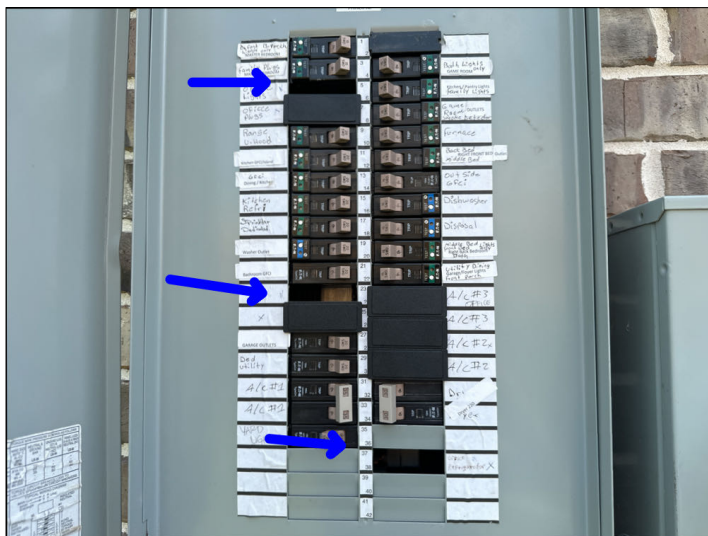
There is at least one filler plate missing on the main electrical panel cover. Recommend adding missing filler plates to help prevent electrical shock.

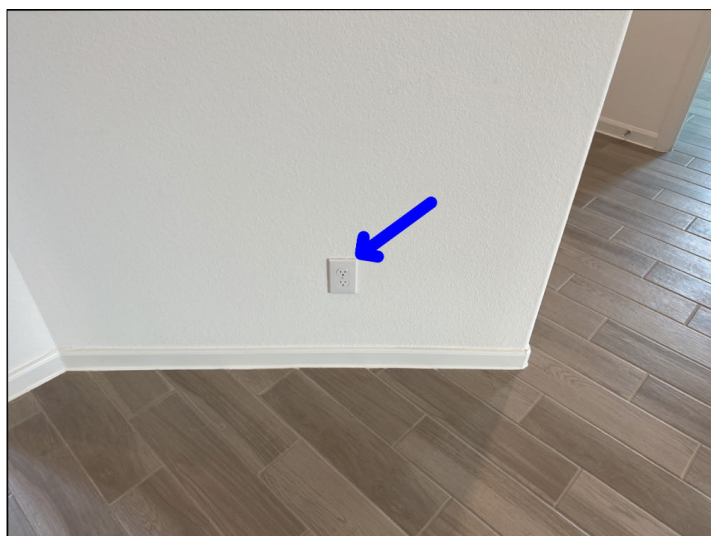
The receptacle is loose. Mainly at - Front Entry

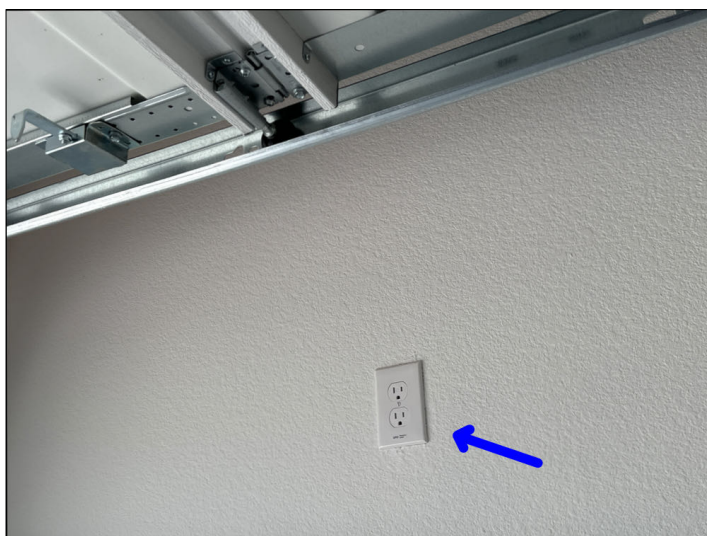
Not GFCI protected above 6' in garage but has a GFCI sticker.

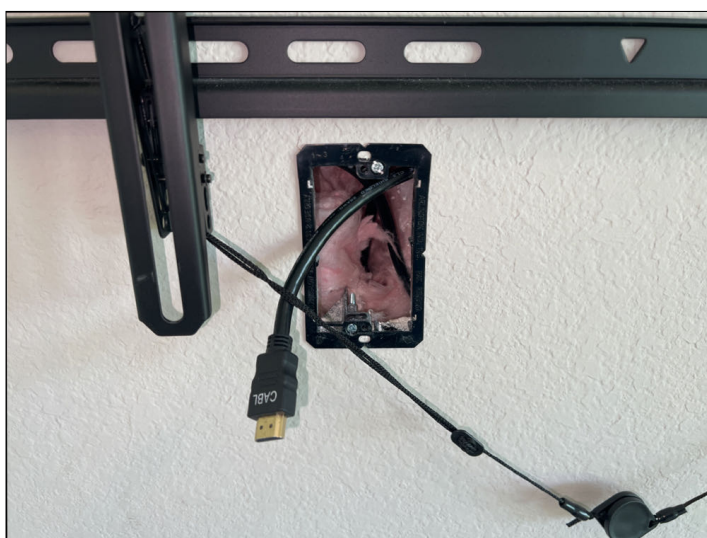
Low voltage cover plate is missing. Mainly at - Living Room

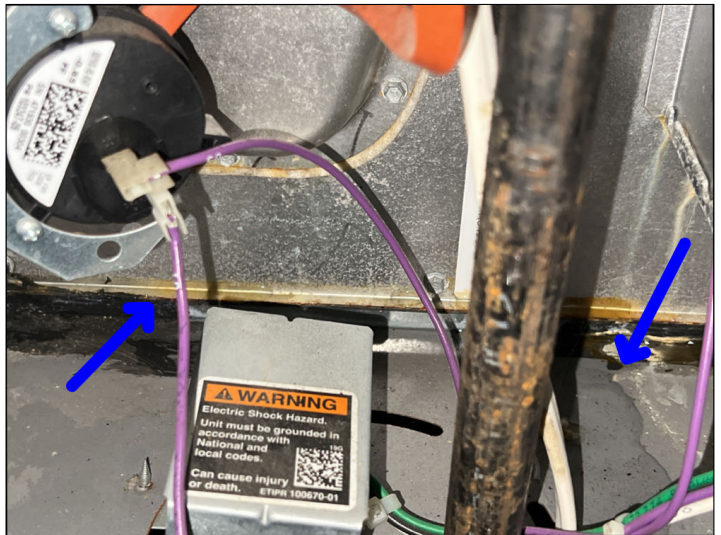
There is water present in the furnace compartment. Recommend further evaluation by a licensed HVAC technician.

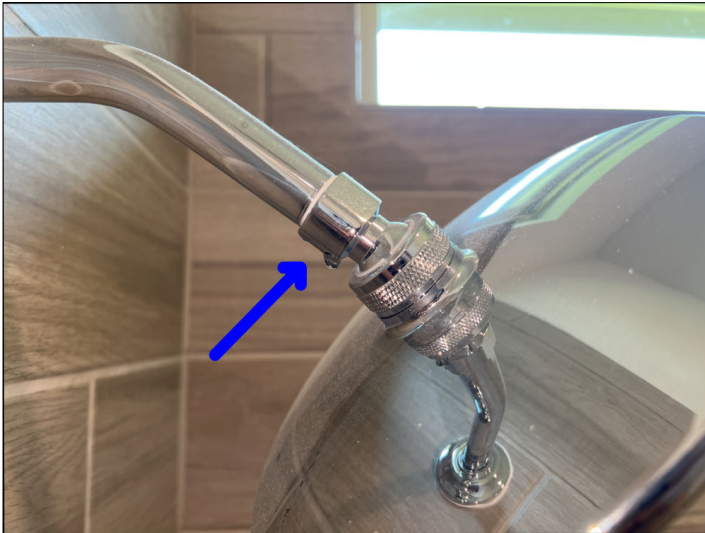
The shower head leaks at the connection. Mainly at - Hall bath

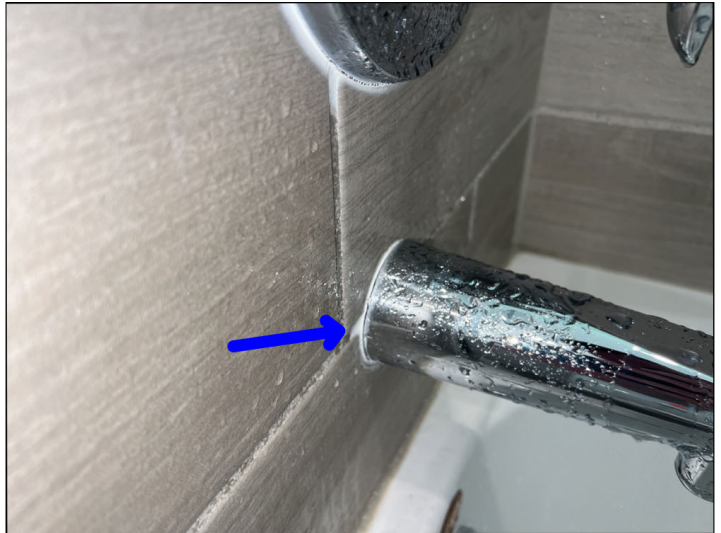
All tub shower faucets and spouts should be sealed to help prevent water penetration behind the fixture.

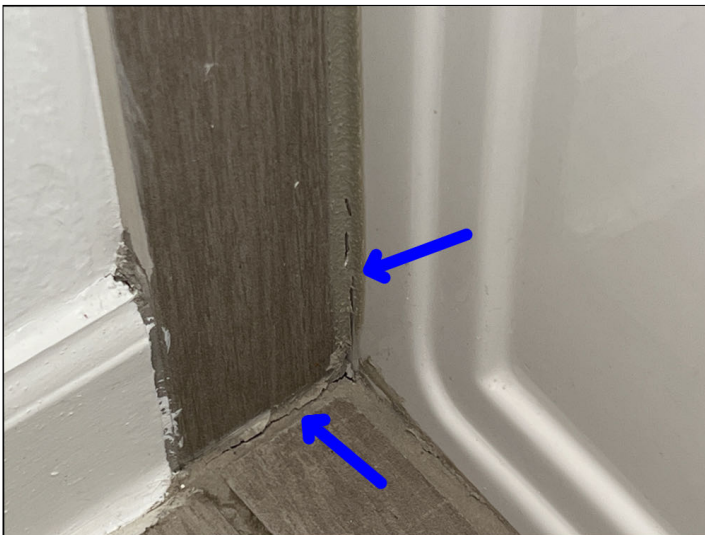
Recommend sealing the tub/shower surround to help prevent water penetration to underlying materials. Mainly at - Hall bath

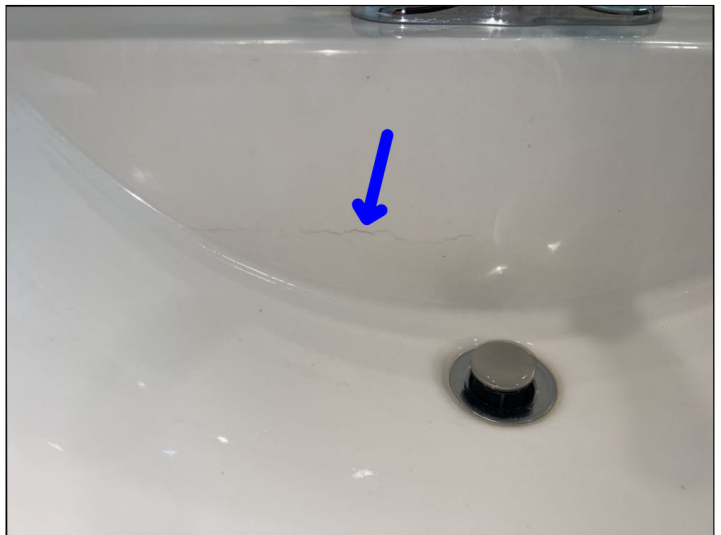
There is a crack noted in the sink which could potentially lead to a leak beneath the sink into the cabinet. Mainly at - Hall bath

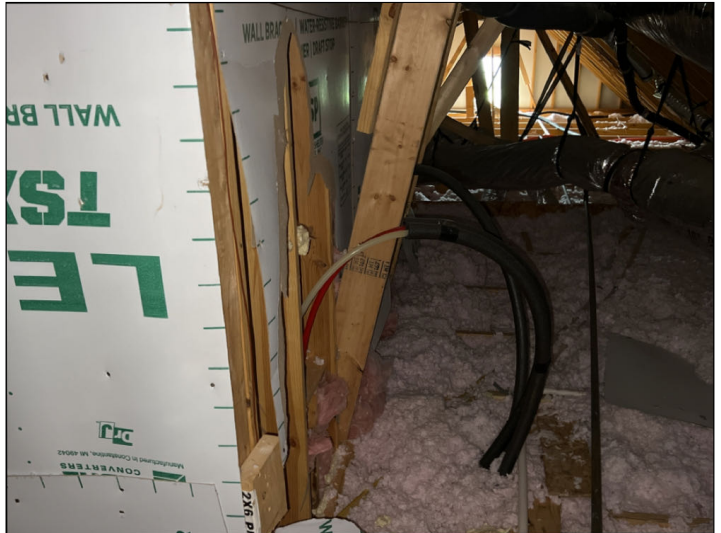
There are uninsulated water supply lines routed through the attic. Recommend all uninsulated supply lines be properly insulated to help prevent damage to the pipes in freezing weather.

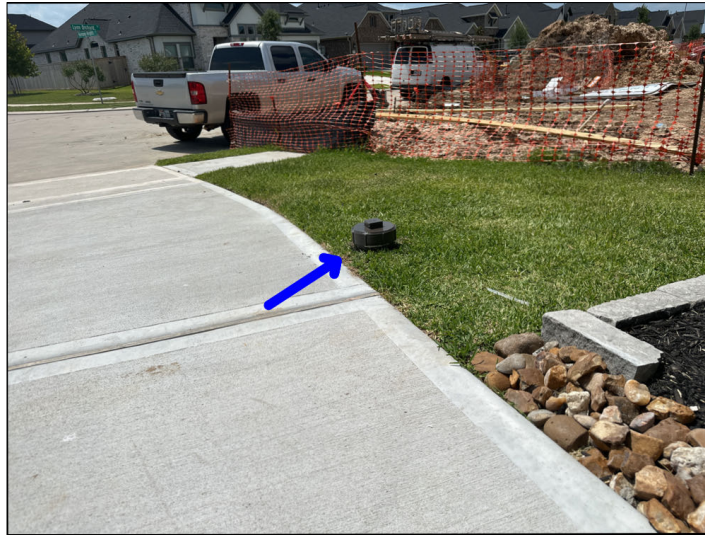
The clean out is extremely close to the driveway which could pose a safety hazard while getting in and out of the car, recommend cutting down below grade to help prevent injury.

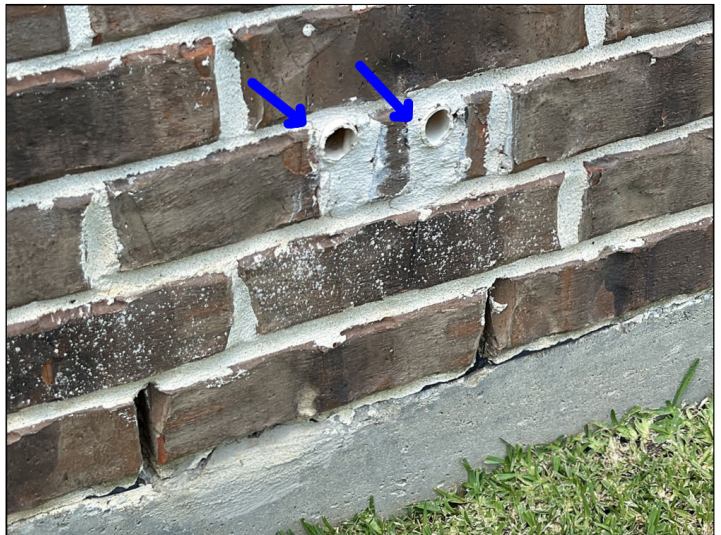
The water heater pan drain or T&P (Pop-Off) valve drain line does not have a properly installed 90 elbow to safely direct the high-pressure discharge from the valve where it exits the exterior. There are indications that both lines have been broken off recommend repairs to help prevent water penetration into wall.

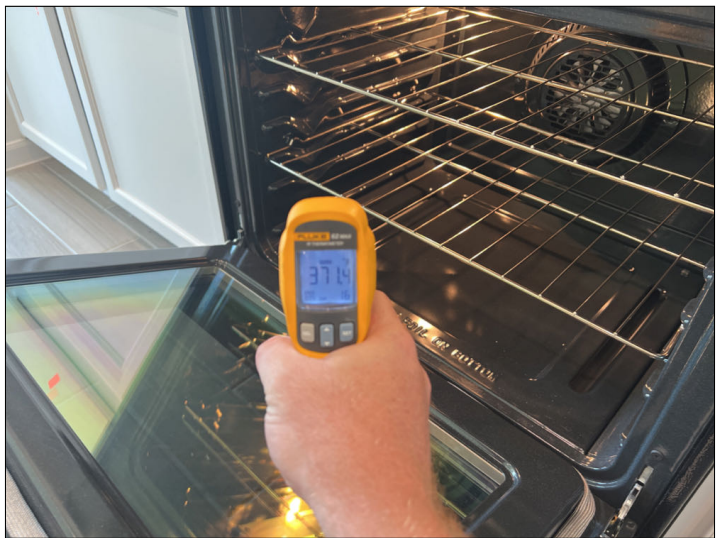
Oven Thermostat to Temperature Reading: 350F / 370-375F

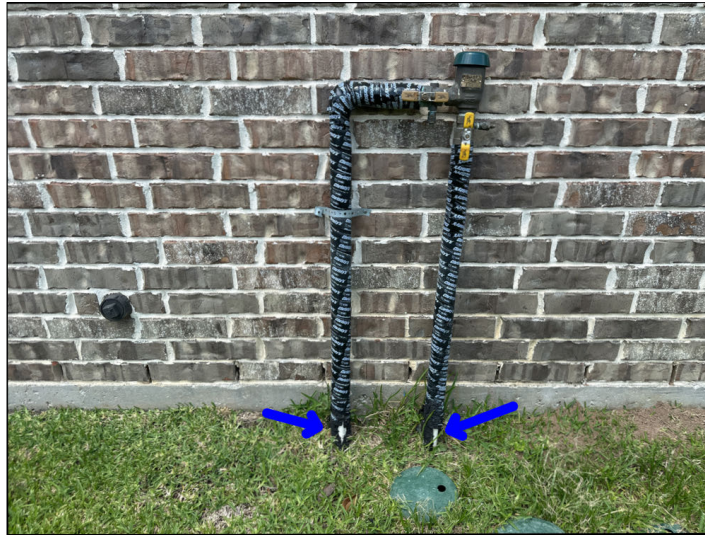
Sprinkler vacuum breaker lines insulation is damaged or missing.
