## Property Inspection Report

1234 Main St. Someplace, TX 77000

# PROPERTY INSPECTION REPORT FORM

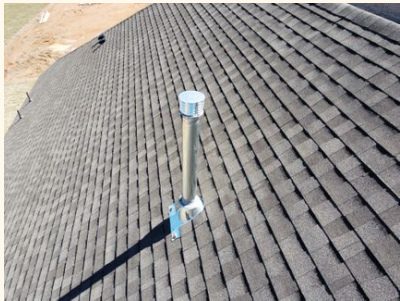
(SS-1) Recommended Repair:

One or more of the vents and or flashing is unpainted, recommend painting all unpainted vents and flashing to help prevent damage due to UV rays or rust.

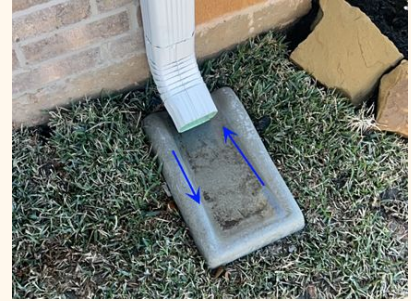
(SS-2) Recommended Repair:

Splash blocks should be installed to direct water away from foundation to help promote proper drainage, recommend the open side face away from the structure in order to help the water flow away from the structure to help prevent future foundation issues. This is often done in new construction until grass root system has matured, once grass has matured it is recommended that they be reinstalled correctly for proper drainage away from foundation.

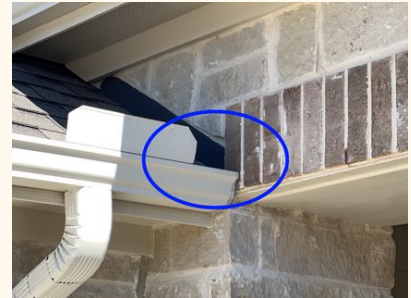
(SS-3) Recommended Repair:

The roof is missing the kick out flashing at the end of the roof to sidewall connection. Kick-out flashing is meant to help prevent water from running down or into the wall causing possible water penetration and deterioration. Mainly at -

Front

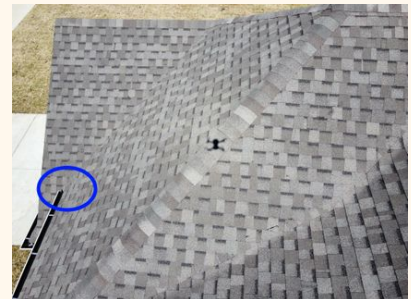
(SS-4) Recommended Repair:

The gutter is missing its end cap. Mainly at -

Front

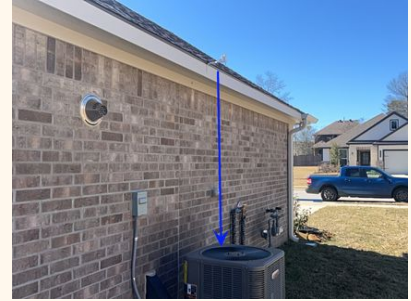
(SS-5) Recommended Repair:

There is no gutter system or flashing installed at the roofs edge to prevent water from shedding directly on to the Condenser as recommended by most manufacturers. Recommend installation of gutters or flashing materials to deflect shedding water away from the Condenser to help prevent premature failure.

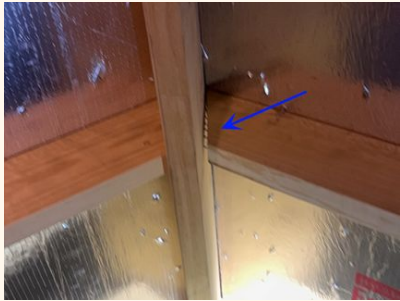
**(SS-6) Recommended Repair:**

There are Rafters in the attic which are separating from the Ridge Board of the roof. This is indicative of structural movement and should be monitored for further movement. Often times, installing collar ties at these locations can help prevent further separation.

Front

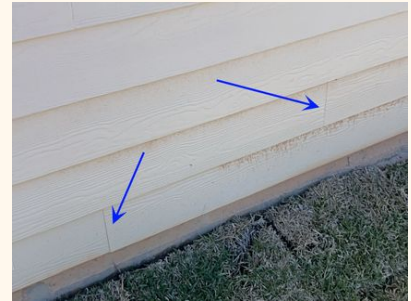
**(SS-7) Recommended Repair:**

There are gaps at the joints in the siding in various locations due to shrinking and expansion of siding materials, recommend sealing all open joints in the siding to help prevent water penetration.

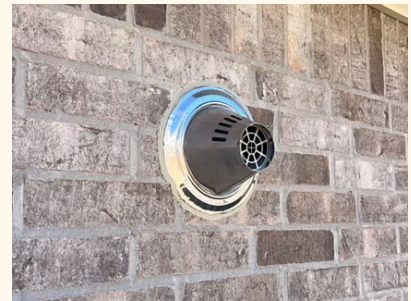
**(SS-8) Recommended Repair:**

There are unpainted vents or vent covers on the home. Recommend painting to help prevent premature deterioration from the sun's UV rays. Mainly at -

*Left*

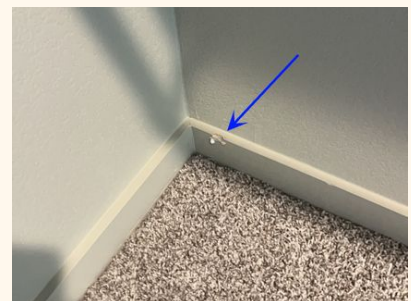
**(SS-9) Recommended Repair:**

There is some damage to the interior trim, recommend repairs to help prevent further damage. Mainly at -

*Primary closet*

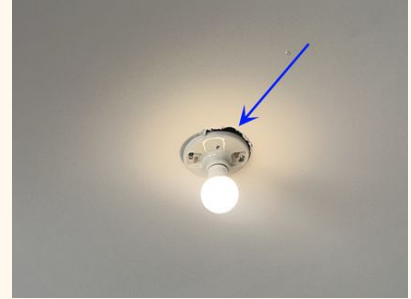
**(SS-10) Recommended Repair:**

There are gaps around the fixture.

*Garage*

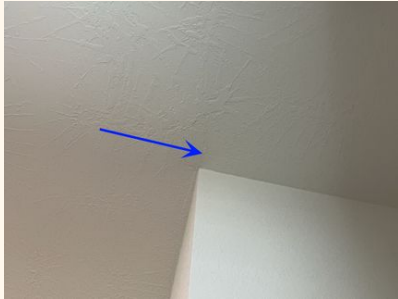
**(SS-11) Recommended Repair:** Settlement cracks were noted at the tape joint in the drywall. The following locations were noted:

*Front entry*

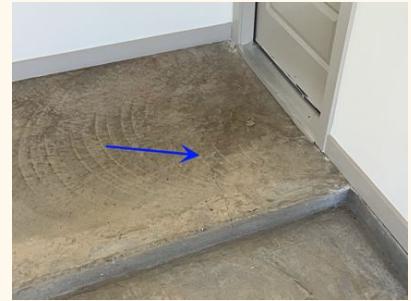
(SS-13) Recommended Repair:

Cracks were noted in the pavement. These are cosmetic in nature at this time. Recommend sealing to help prevent further deterioration. Mainly at -

Garage

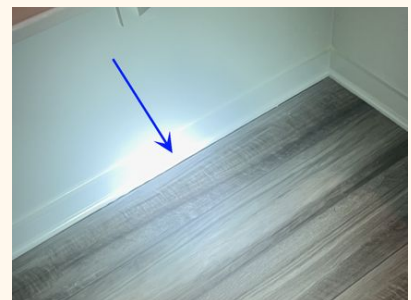
(SS-14) Recommended Repair:

There are gaps noted in the flooring. Mainly at -

Pantry

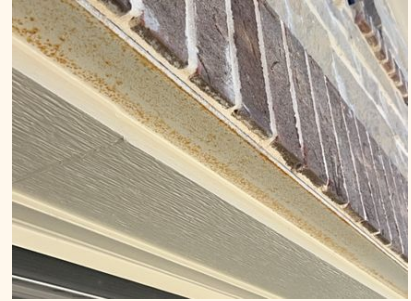
(SS-15) Recommended Repair:

The metal lintels that holds the brick above the doors are rusting, recommend painting to help prevent deterioration.

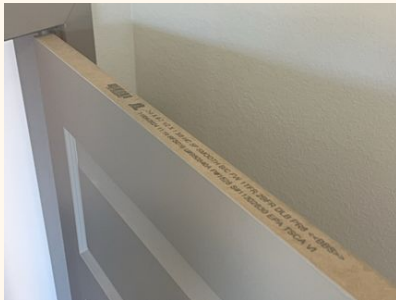
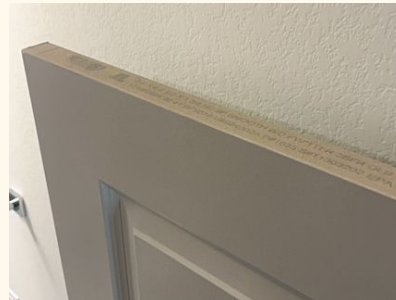
(SS-16) Recommended Repair: The tops and bottoms of the doors in the home are not painted. This may void manufacture warranty.

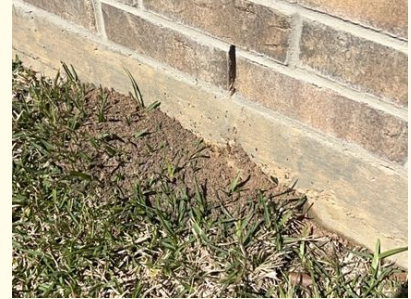
**(SS-17) Recommended Improvements:**

Ants were noted at the foundation. Recommend pest control as needed.

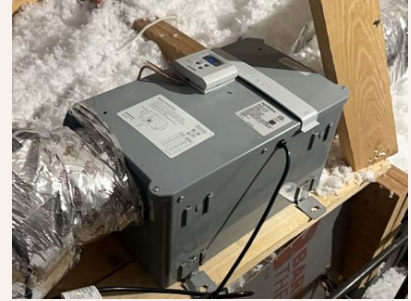
(HVAACS-1) Recommended Maintenance:

There is a fresh air intake filtering system installed in the home. This device requires cleaning every 6 months per manufacturer specifications.

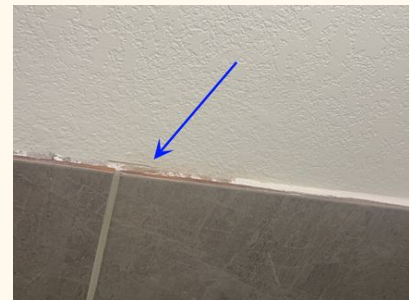
**(PS-1) Recommended Repair:**

Recommend sealing the tub/shower surround to help prevent water penetration to underlying materials. Mainly at -

*Front bathroom*

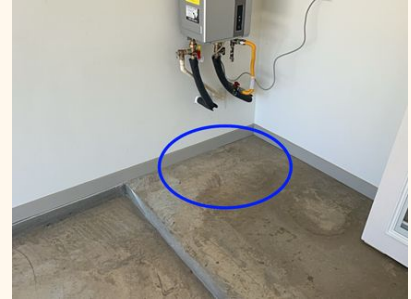
#### (PS-4) Recommended Repair:

There is no drip pan for the water heater installed in the garage. It is recommended that if the water heater is installed in the home or attic that a pan be installed and drain to the exterior of the home. If the water heater is installed on the upper level of the garage it should drain to the exterior or at least drain to the lower level of the garage to help prevent the water heater from flooding the home in case of a failure.

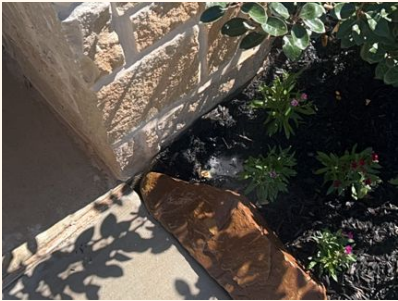
**(OS-1) Recommended Repair:**

Head(s) are not popping up high enough to clear grass or mulch causing limited spray coverage. Zone -

*1*

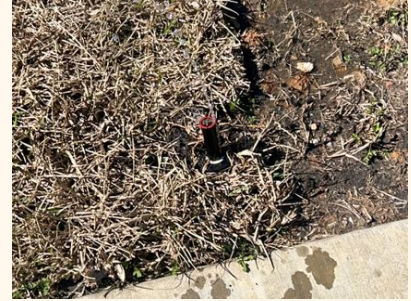
(OS-2) Recommended Repair:

There is a leak at the sprinkler head. Zone -

8
