Property Inspection Report

123 Future Home Dr, Some Town, TX, 12345

Inspection Date: 6/16/2023

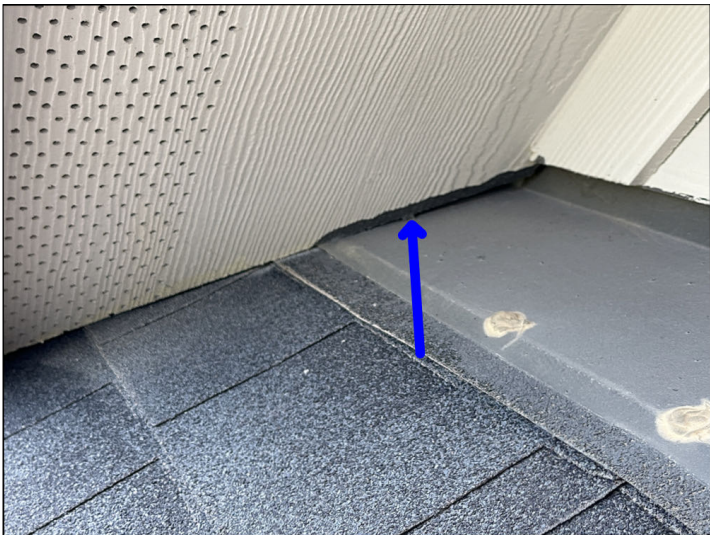
Seal gaps and holes in soffit to help prevent water penetration and rodent intrusion. Mainly at - rear

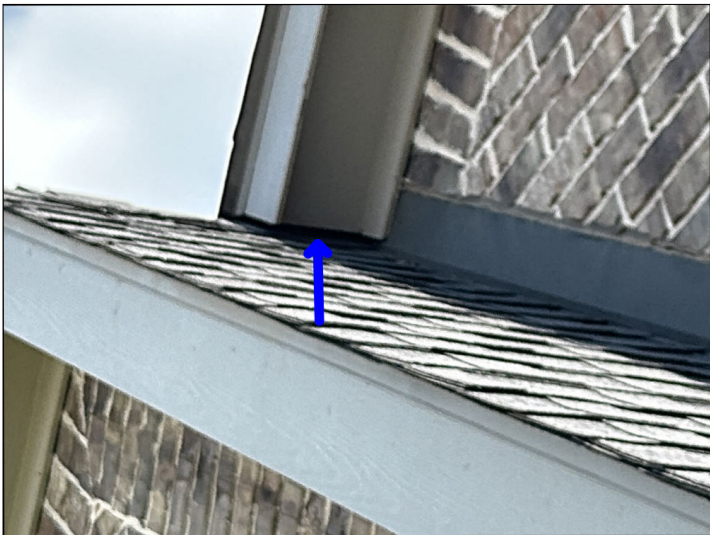
Seal gaps and holes in soffit to help prevent water penetration and rodent intrusion. Mainly at - front

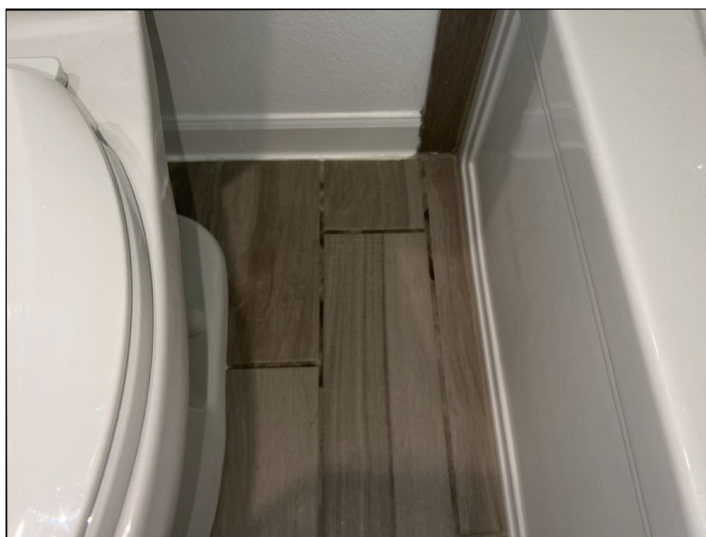
H.1. The grout is discolored. Mainly at - Hall bath

The grout is discolored. Mainly at - Hall bath

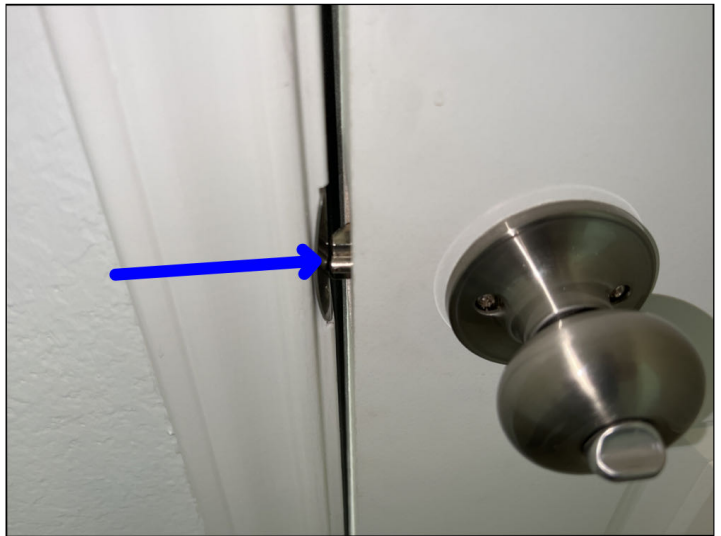
I.4. The door latch is not resetting fully, causing the door not to latch in the frame. Mainly at - Garage entry

The door latch is not resetting fully, causing the door not to latch in the frame. Mainly at - Garage entry

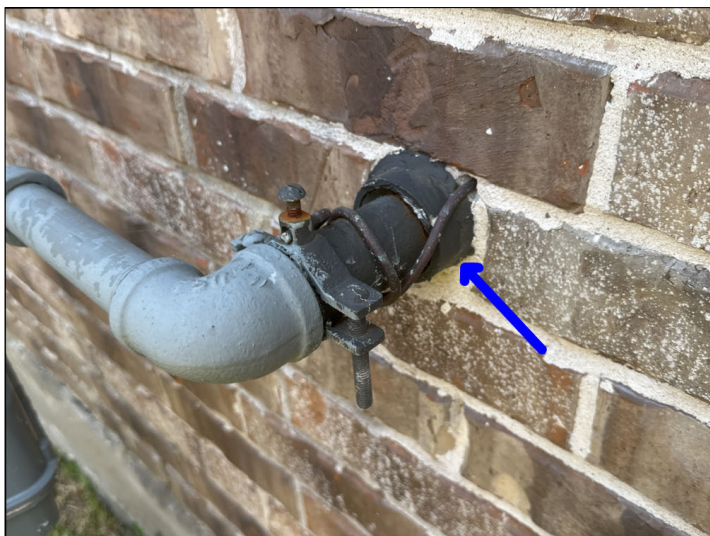
Bonding was noted on the gas line as recommended.

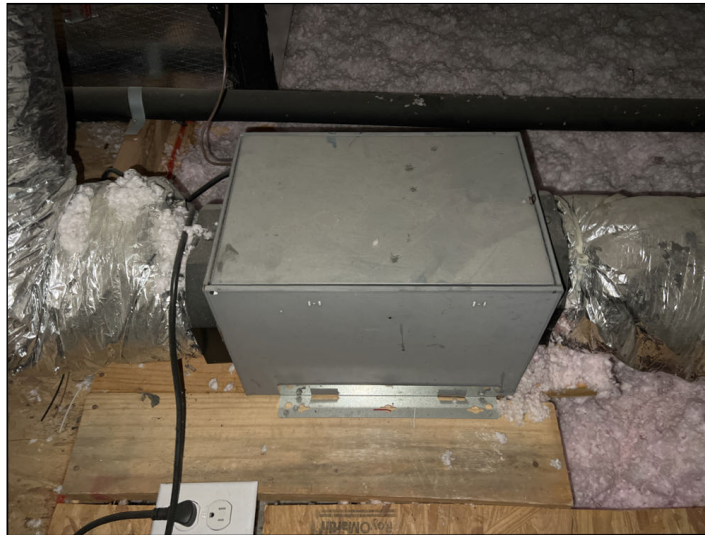
There is a fresh air intake filtering system installed in the home. This device requires cleaning every 6 months per manufacturer specifications.

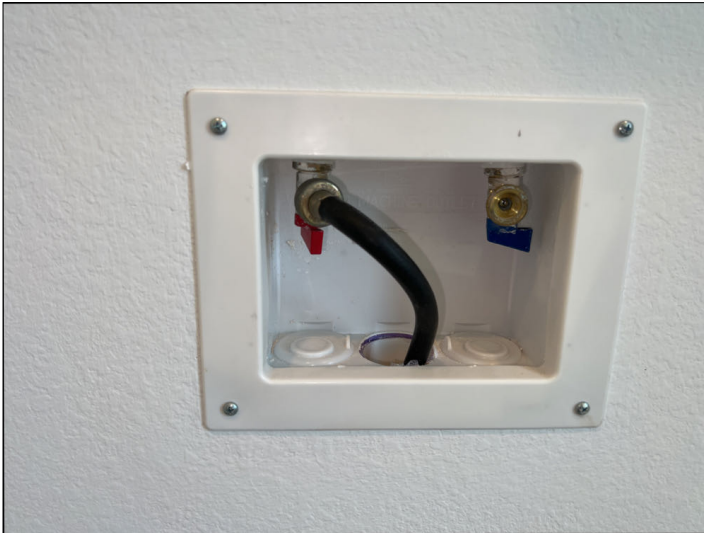
Overview of Laundry supply and drain test.

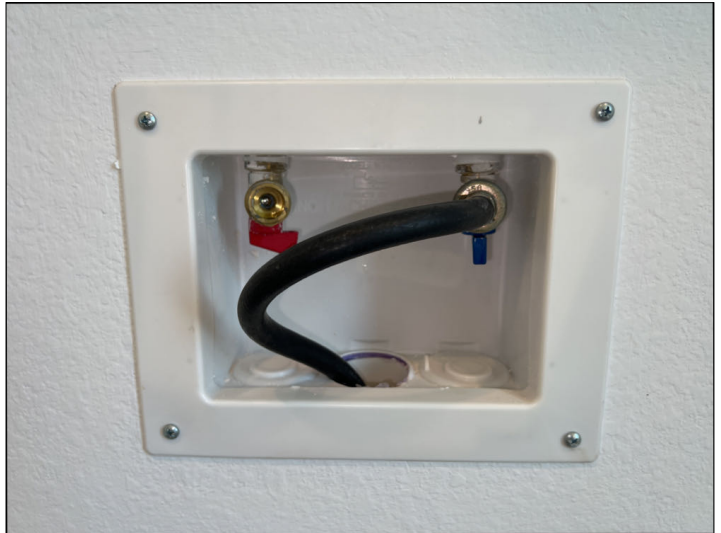
Overview of Laundry supply and drain test.

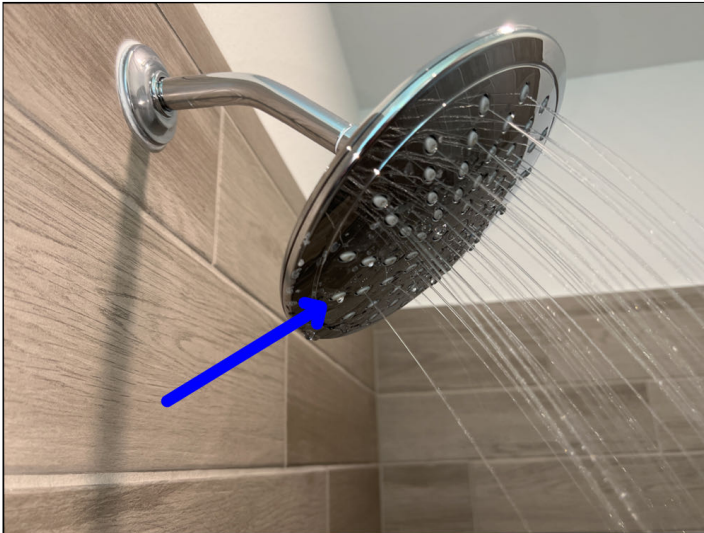
The bottom portion of the shower head is not functioning properly. There is no flow from the lower portion. Mainly at - Master shower

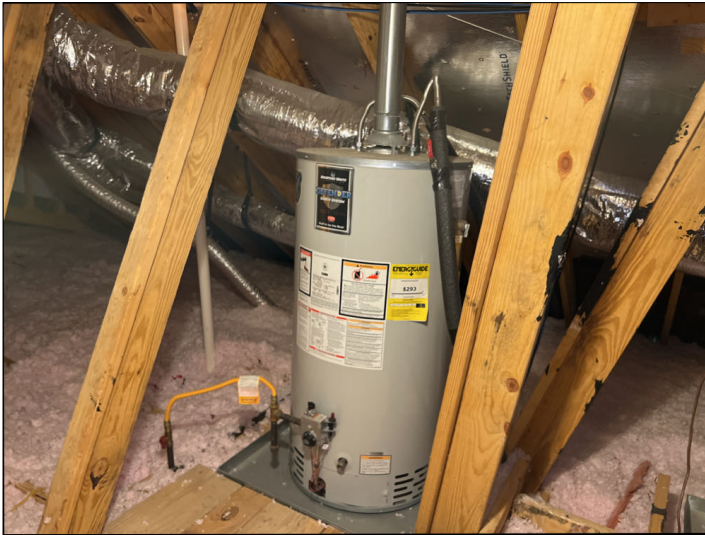
Overview of water heater(s)

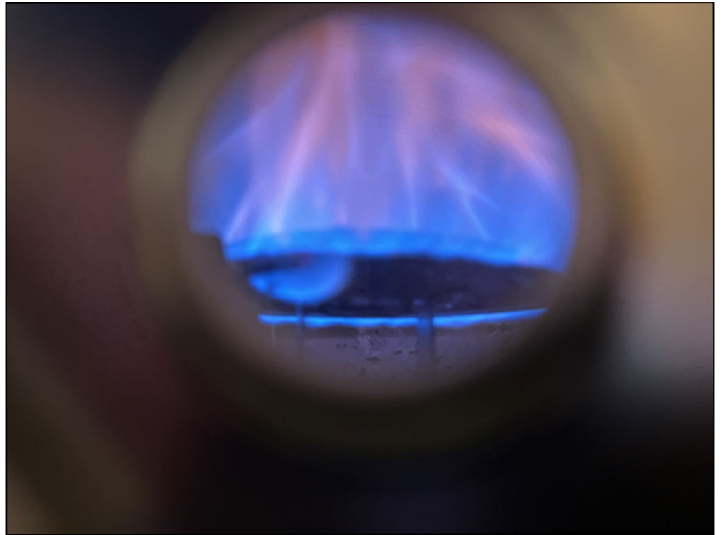
Overview of water heater burner compartment

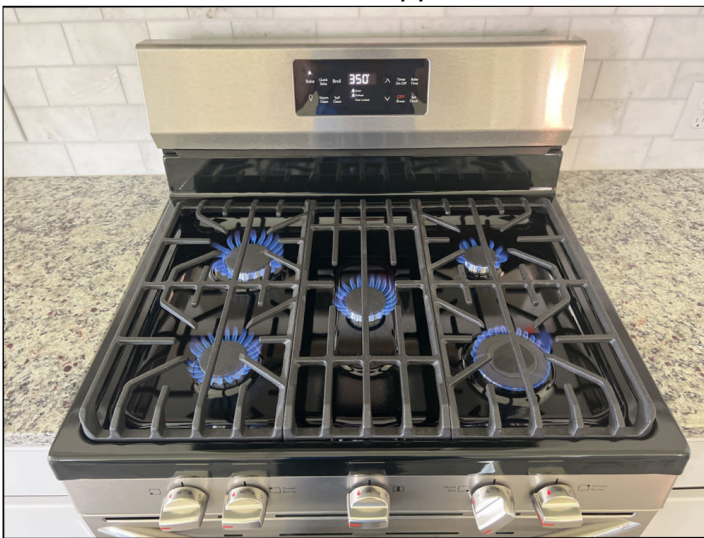
Overview of range in operation.
